# TEST REPORT

Sample Name : Battery protection module

Sample Model : FB-L-5.12-EU

Report No.: CJ2509150R01E

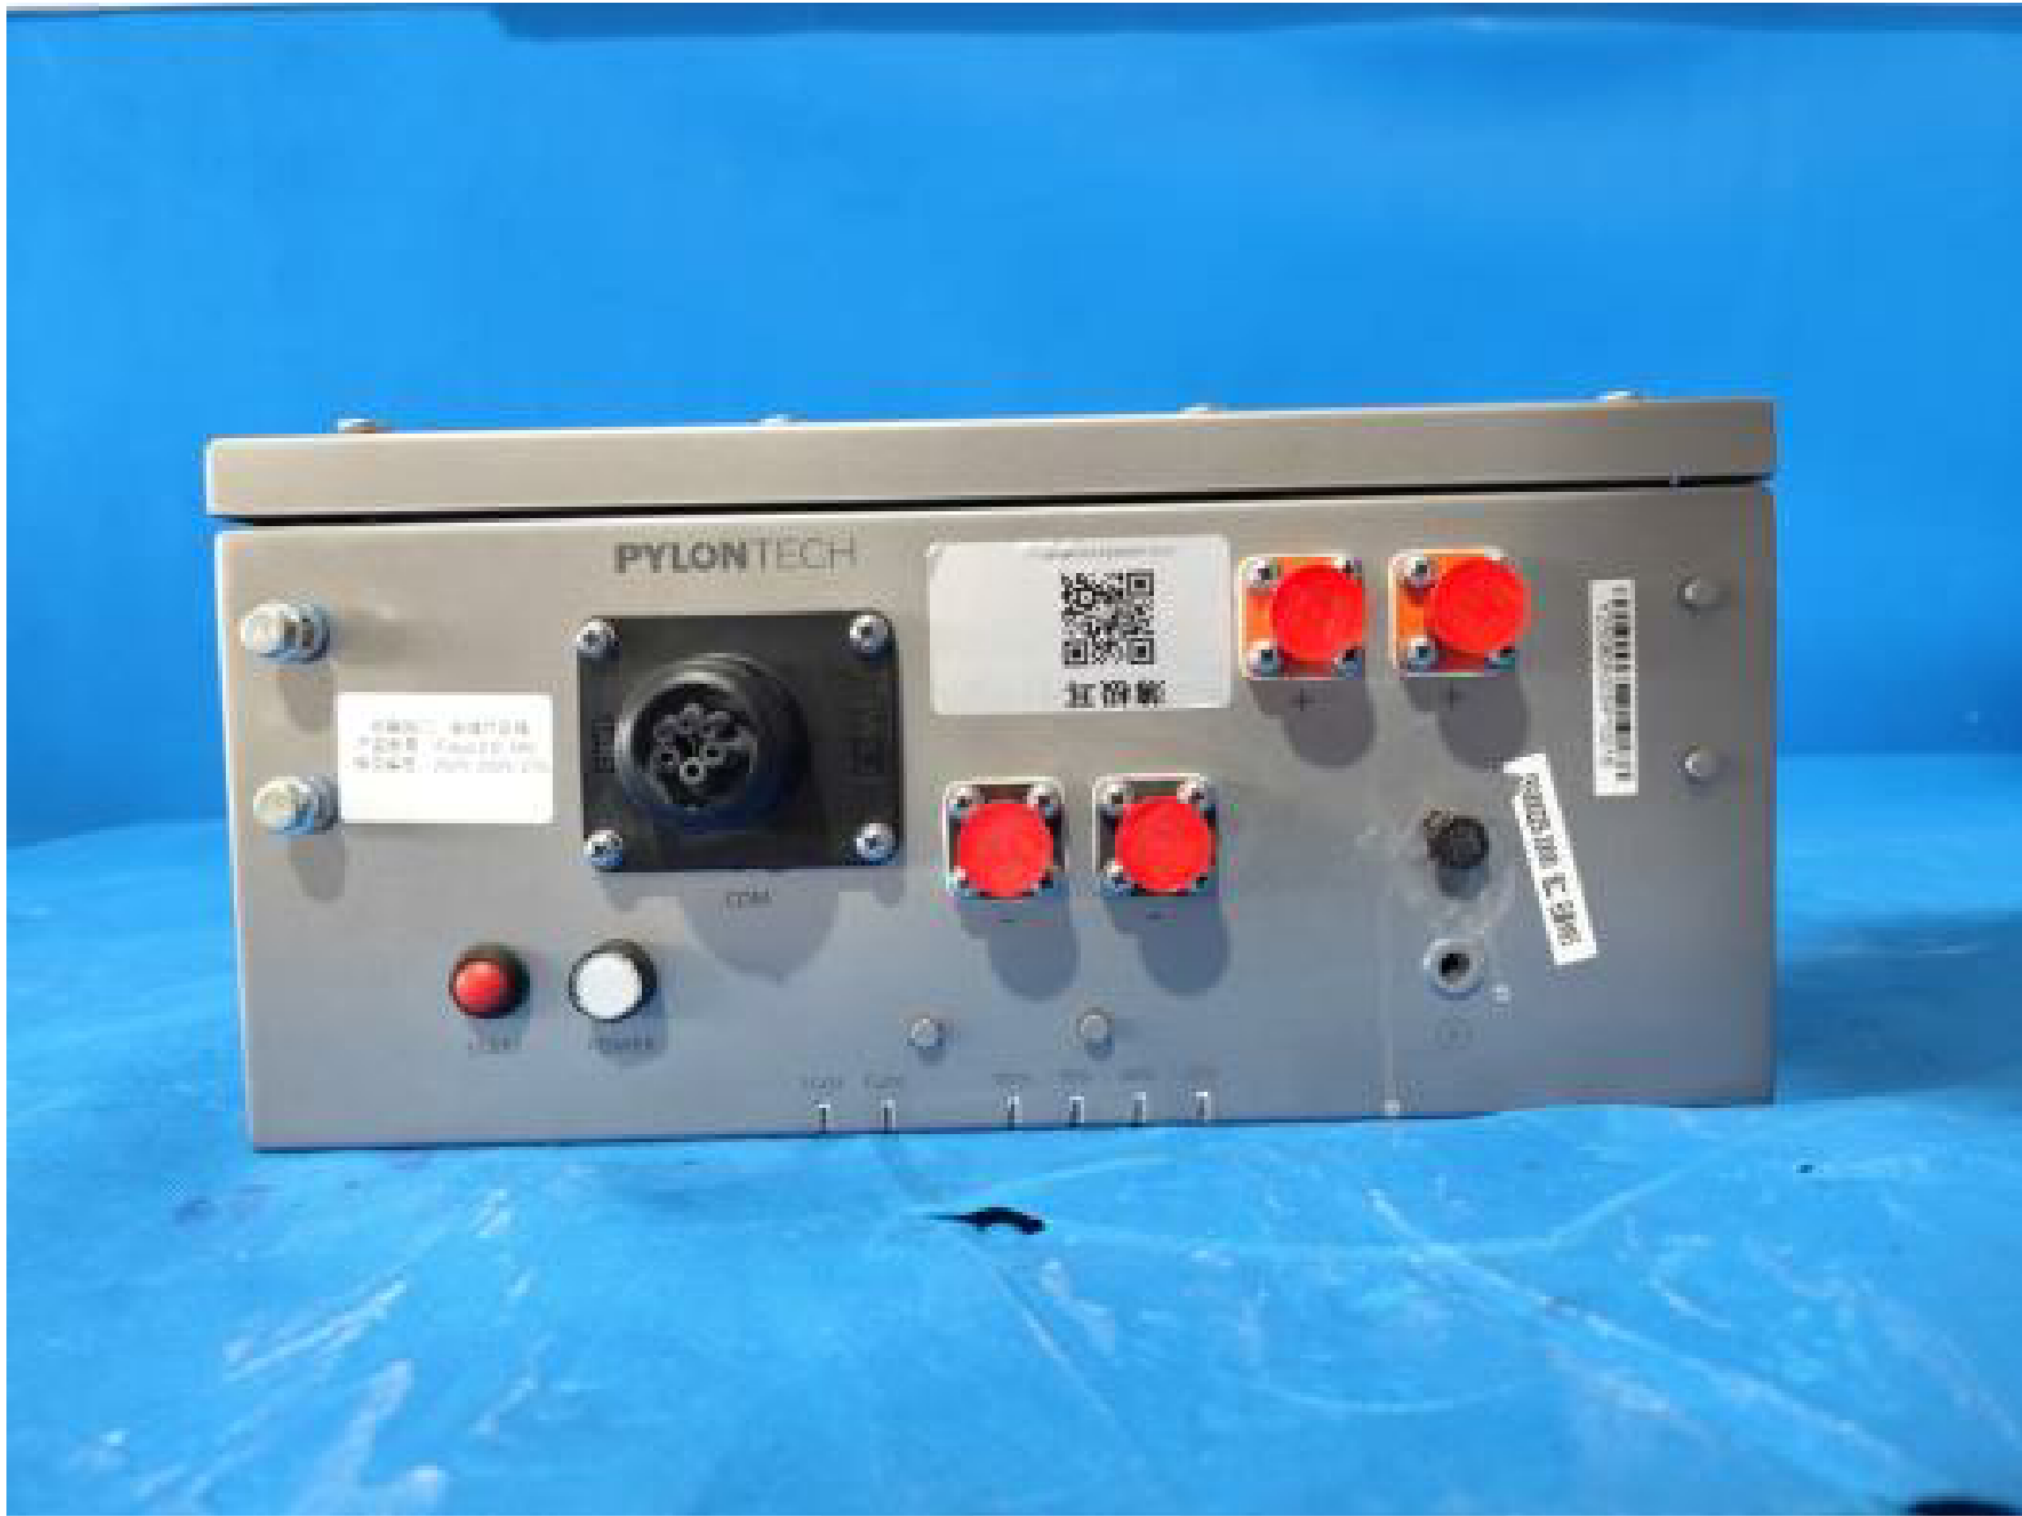
Fig.R01.1 Before the test

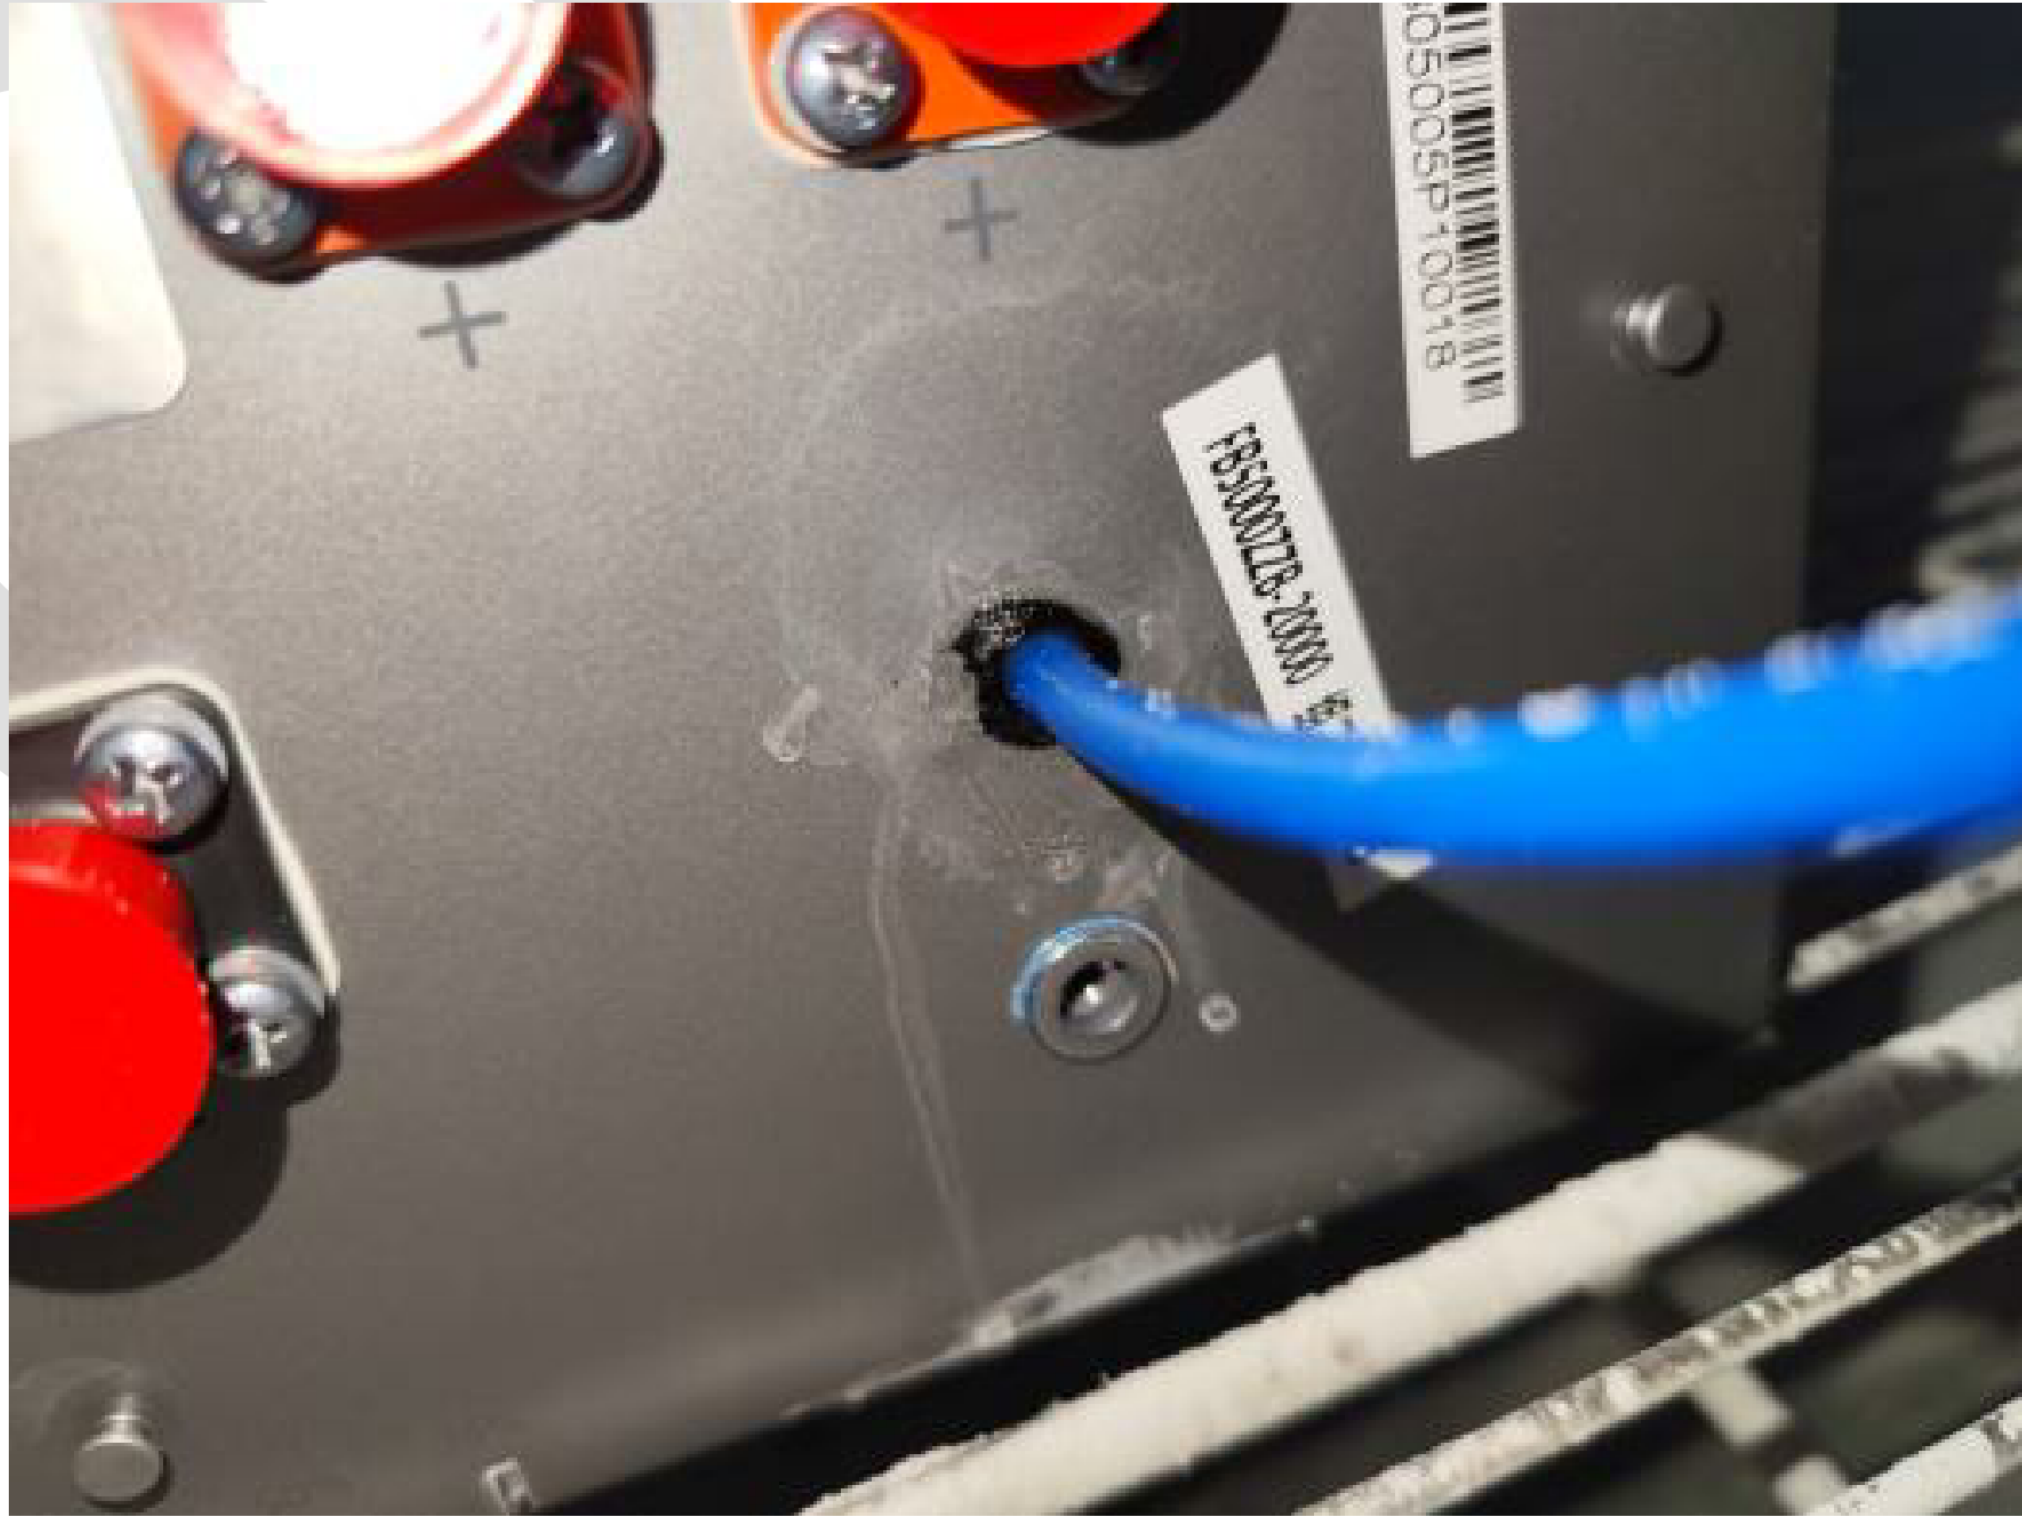
Fig.R01.2 Pumping position

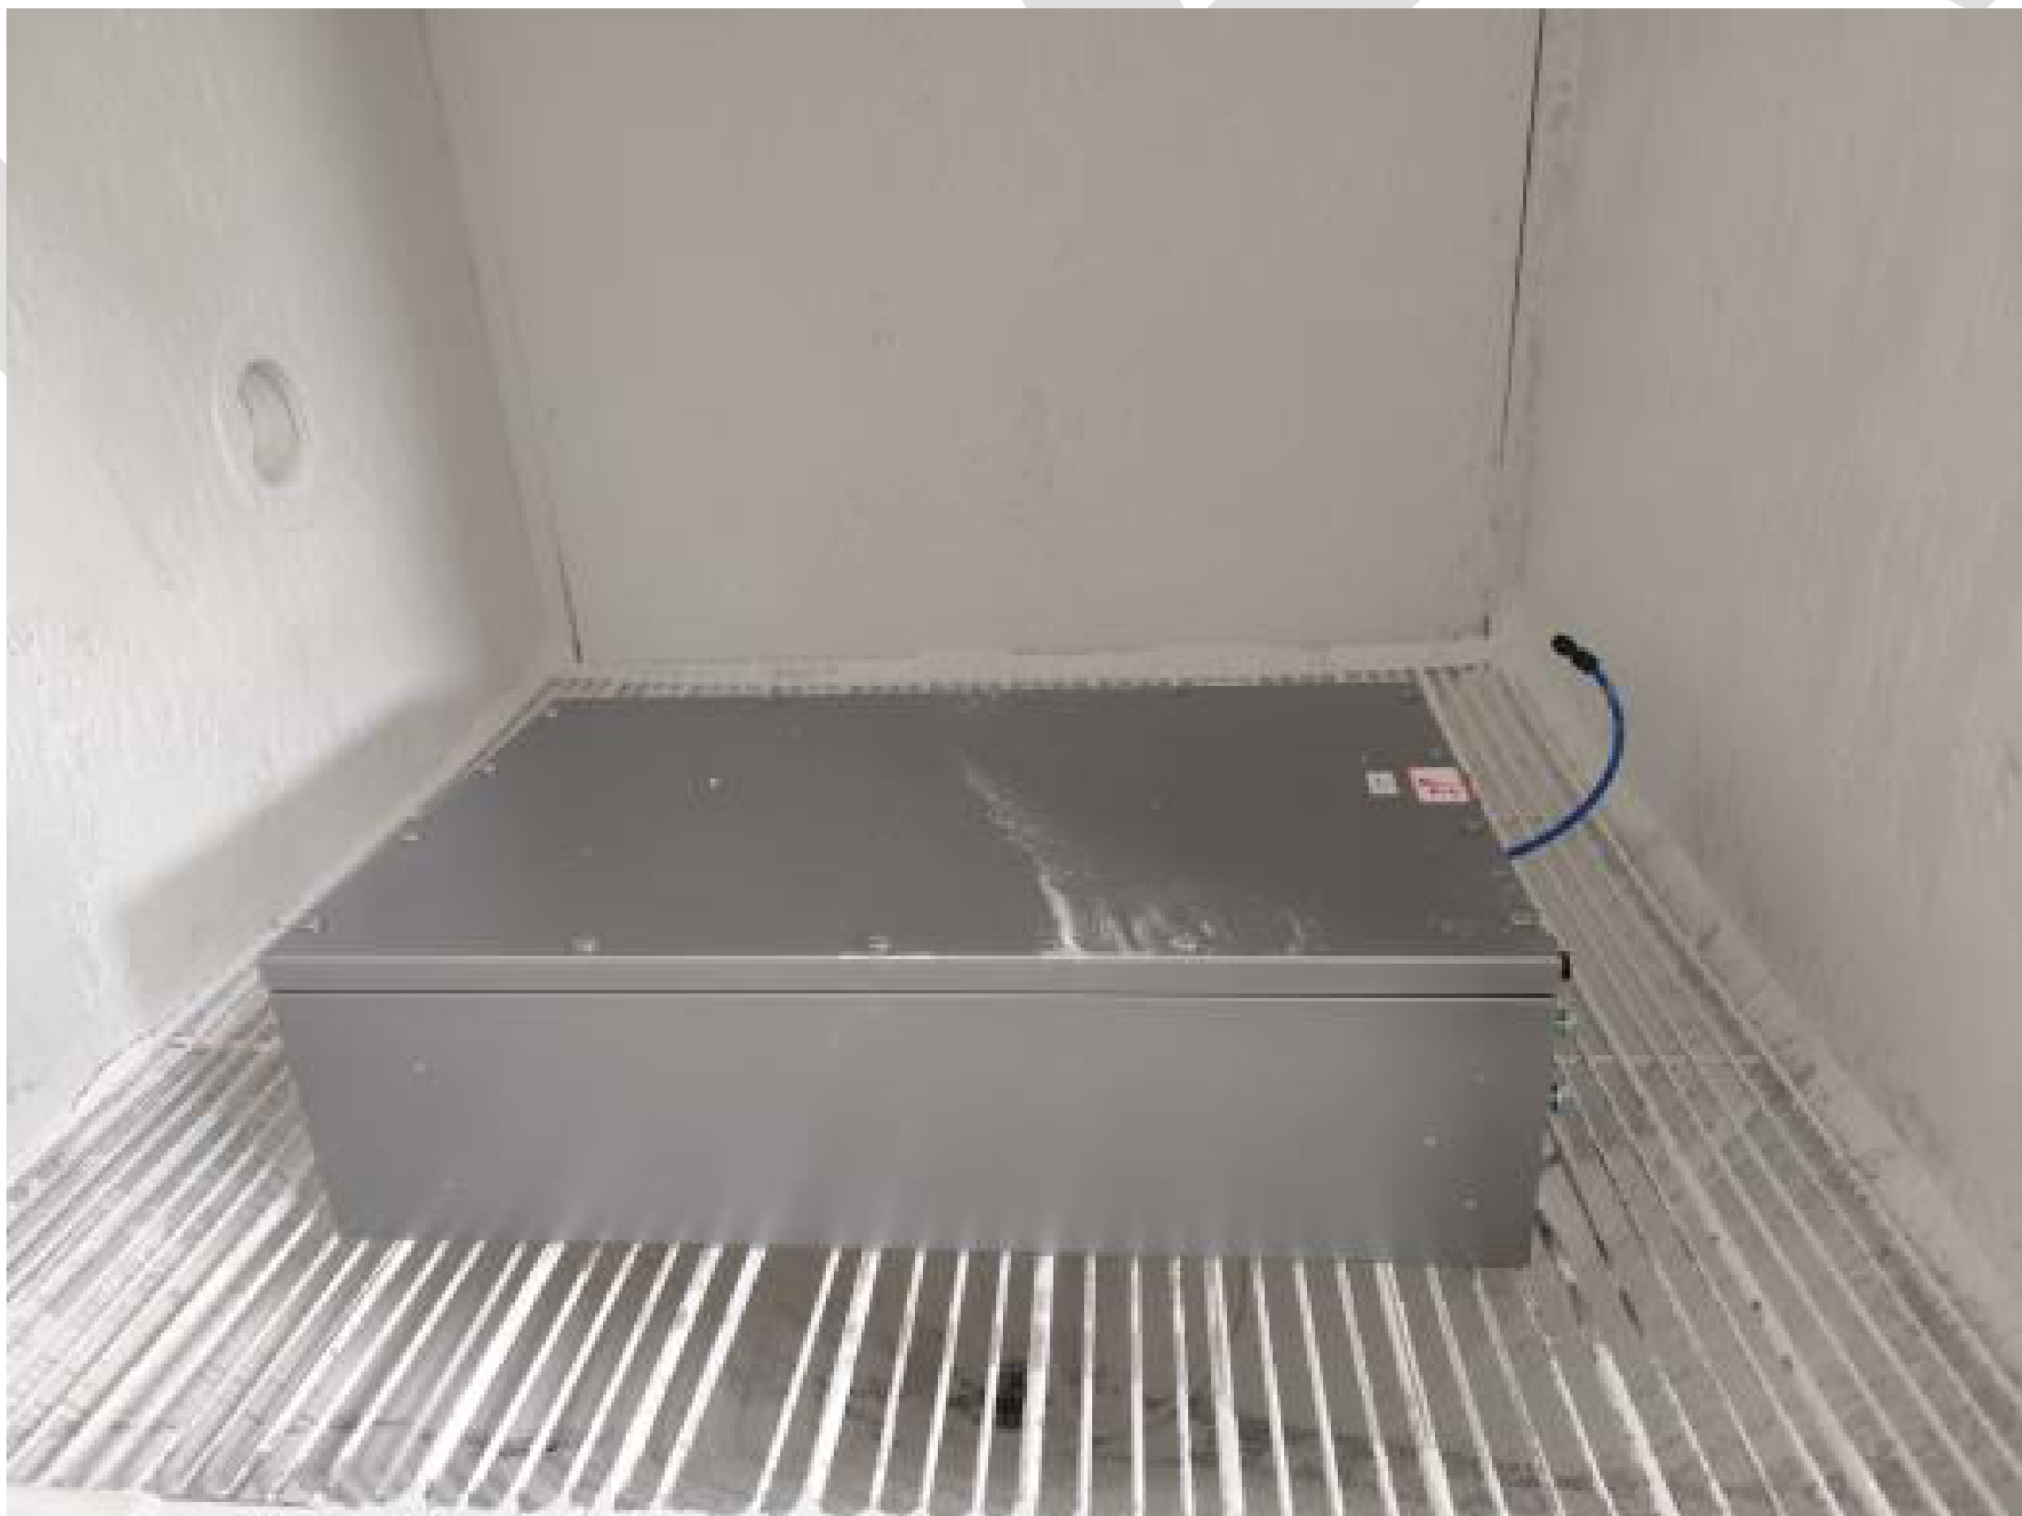
Fig.R01.3 During the test before falling dust

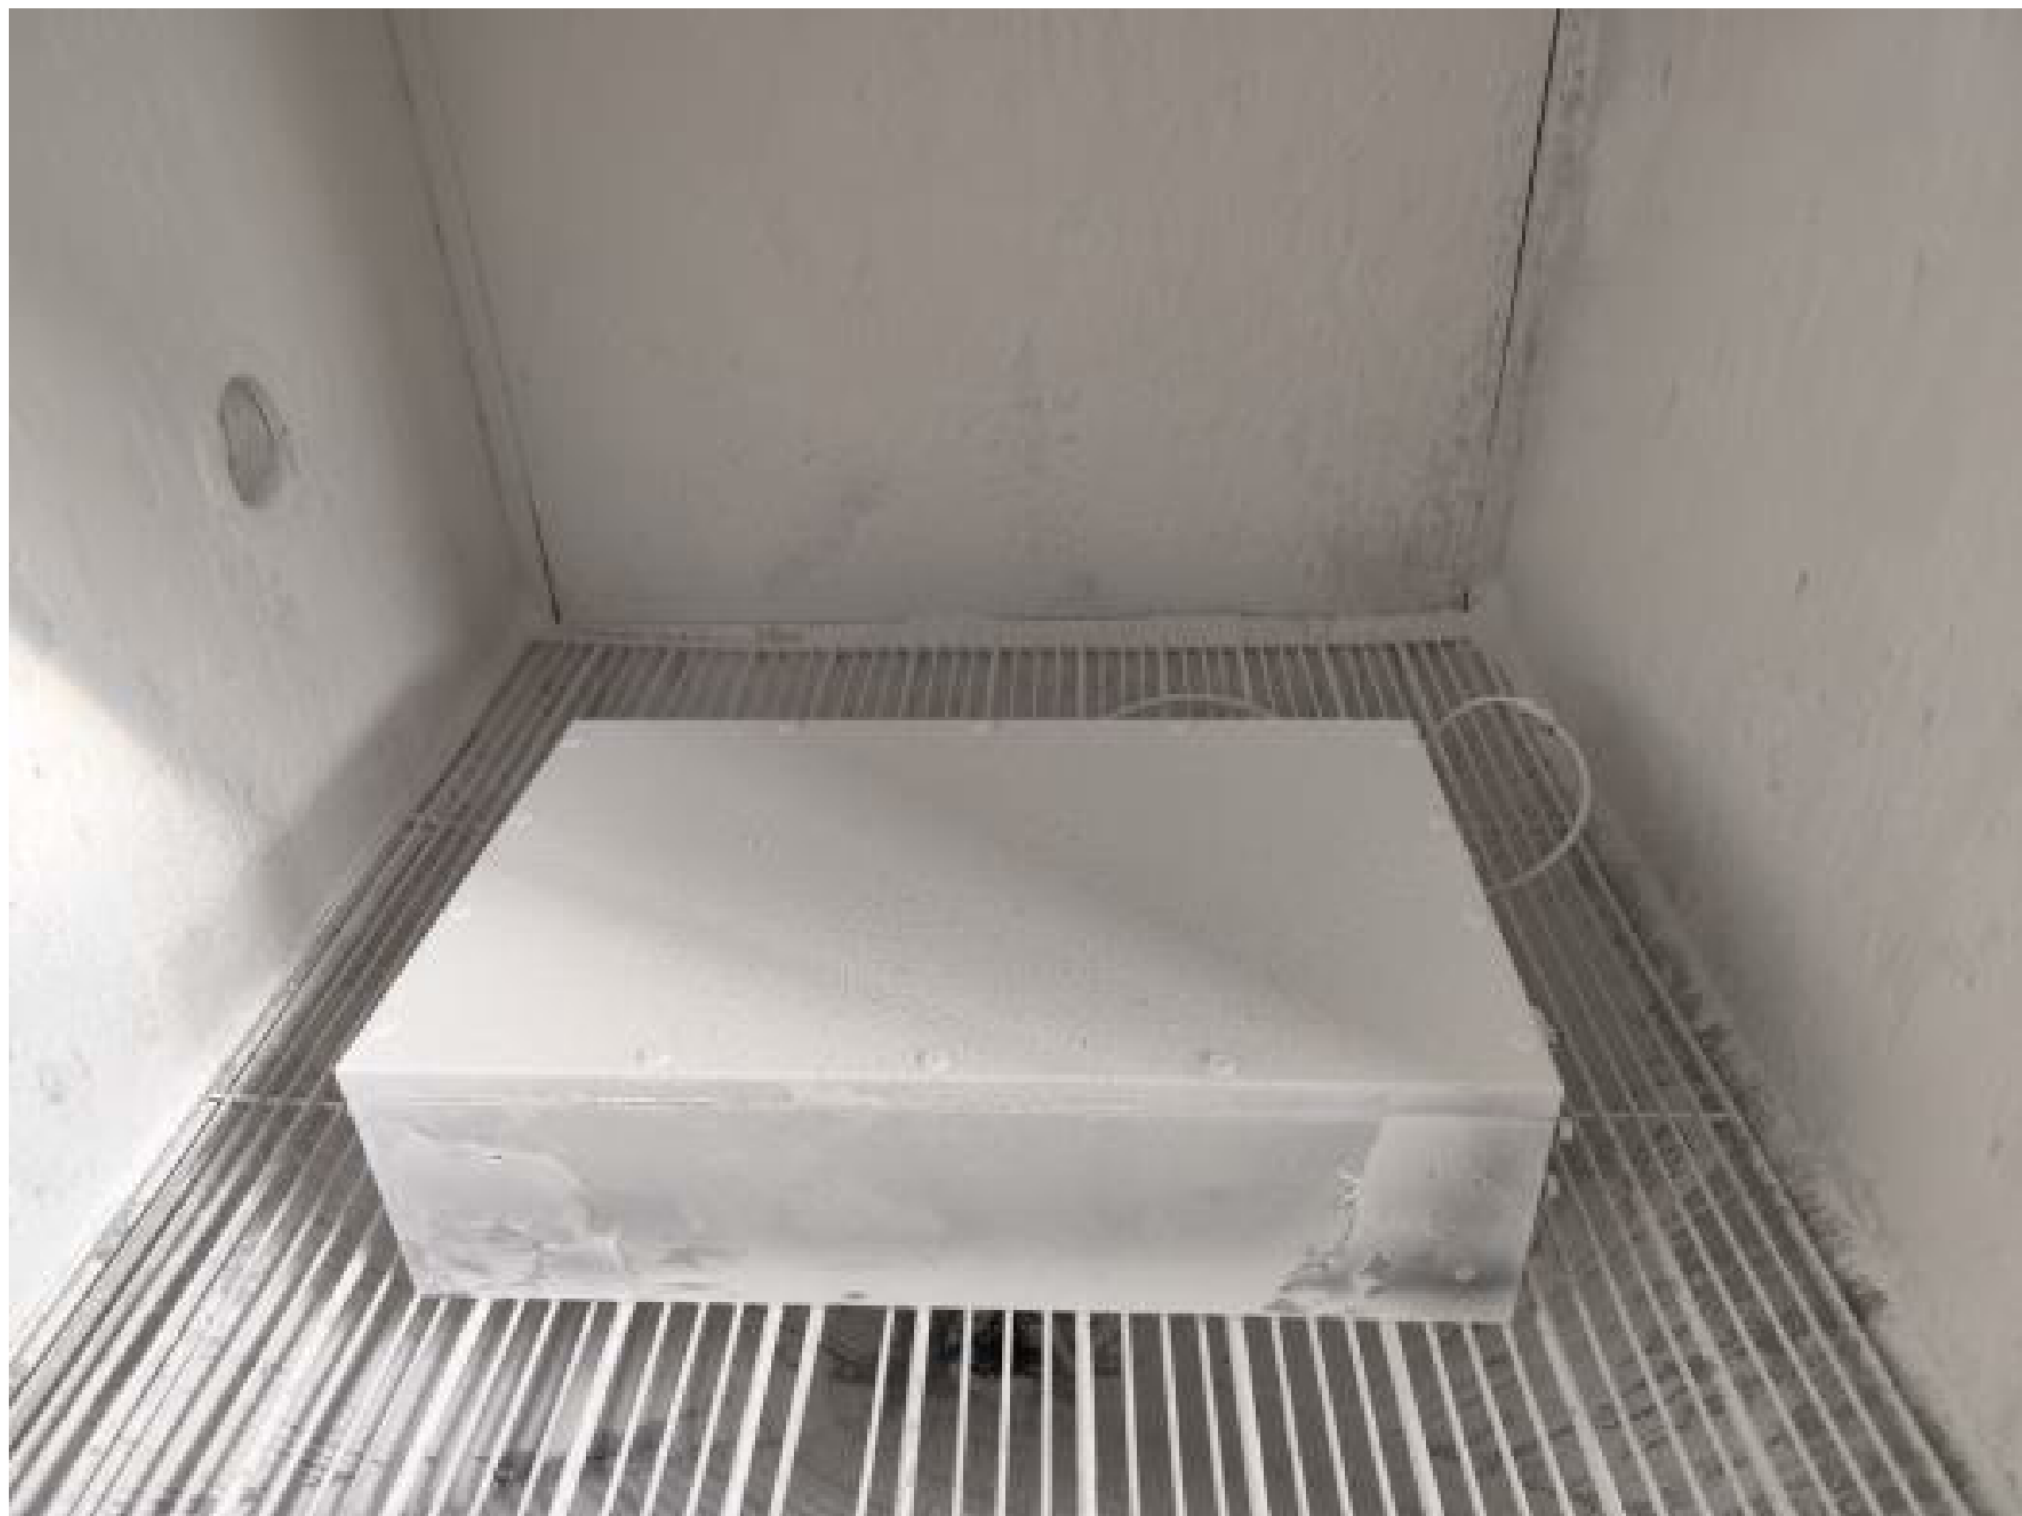
Fig.R01.4 During the test after falling dust

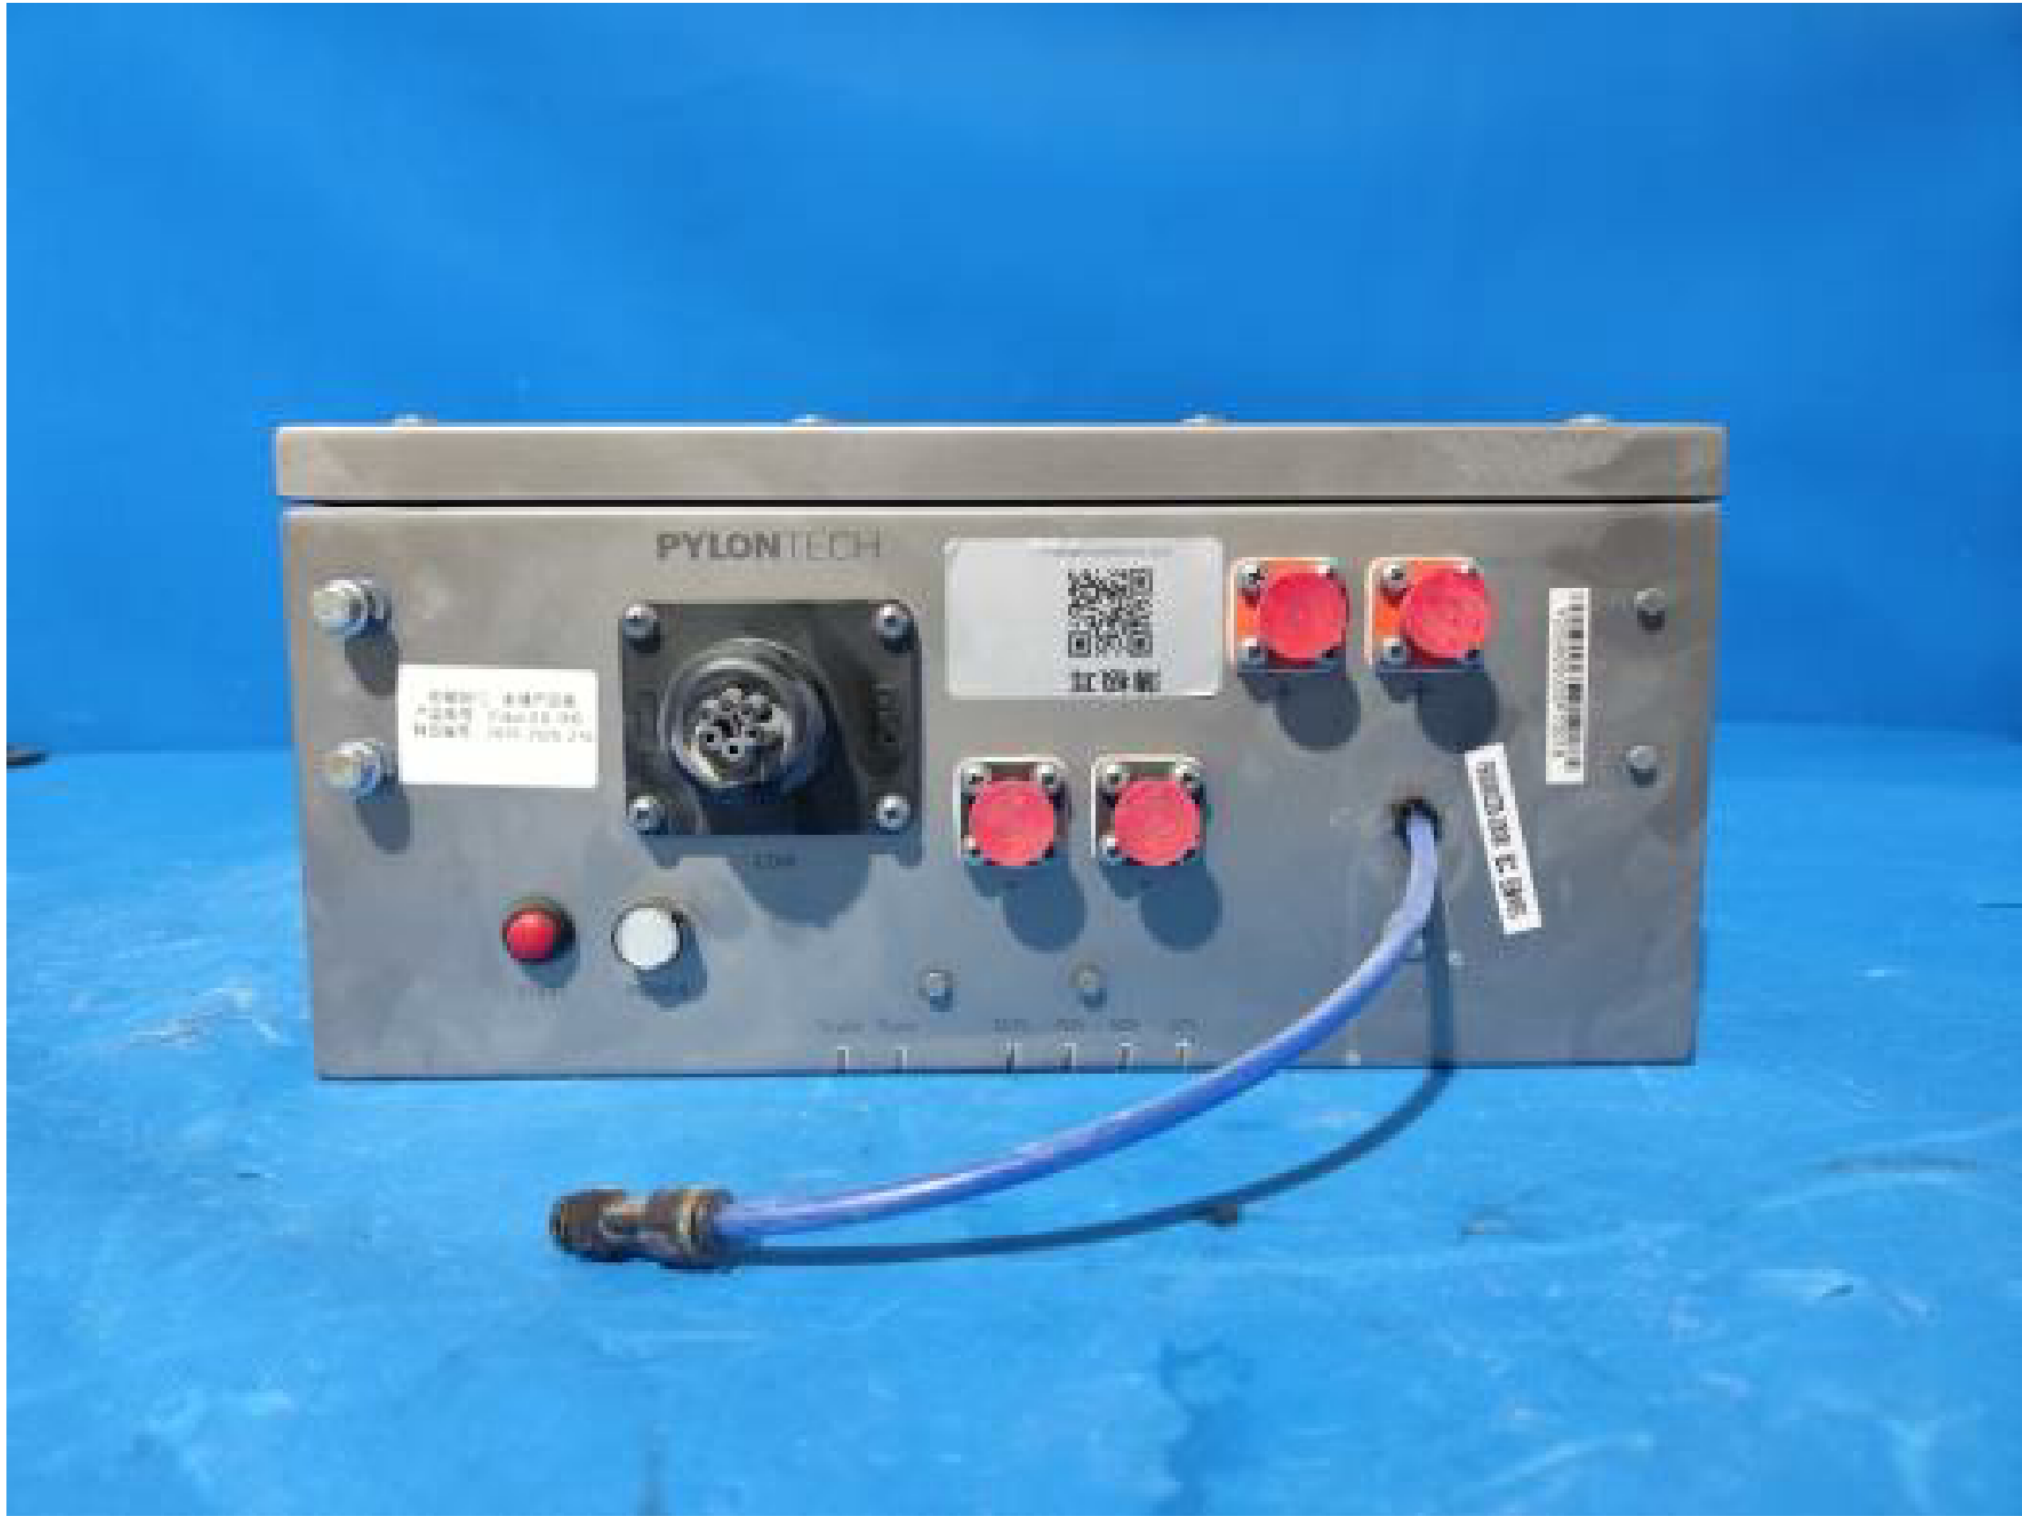
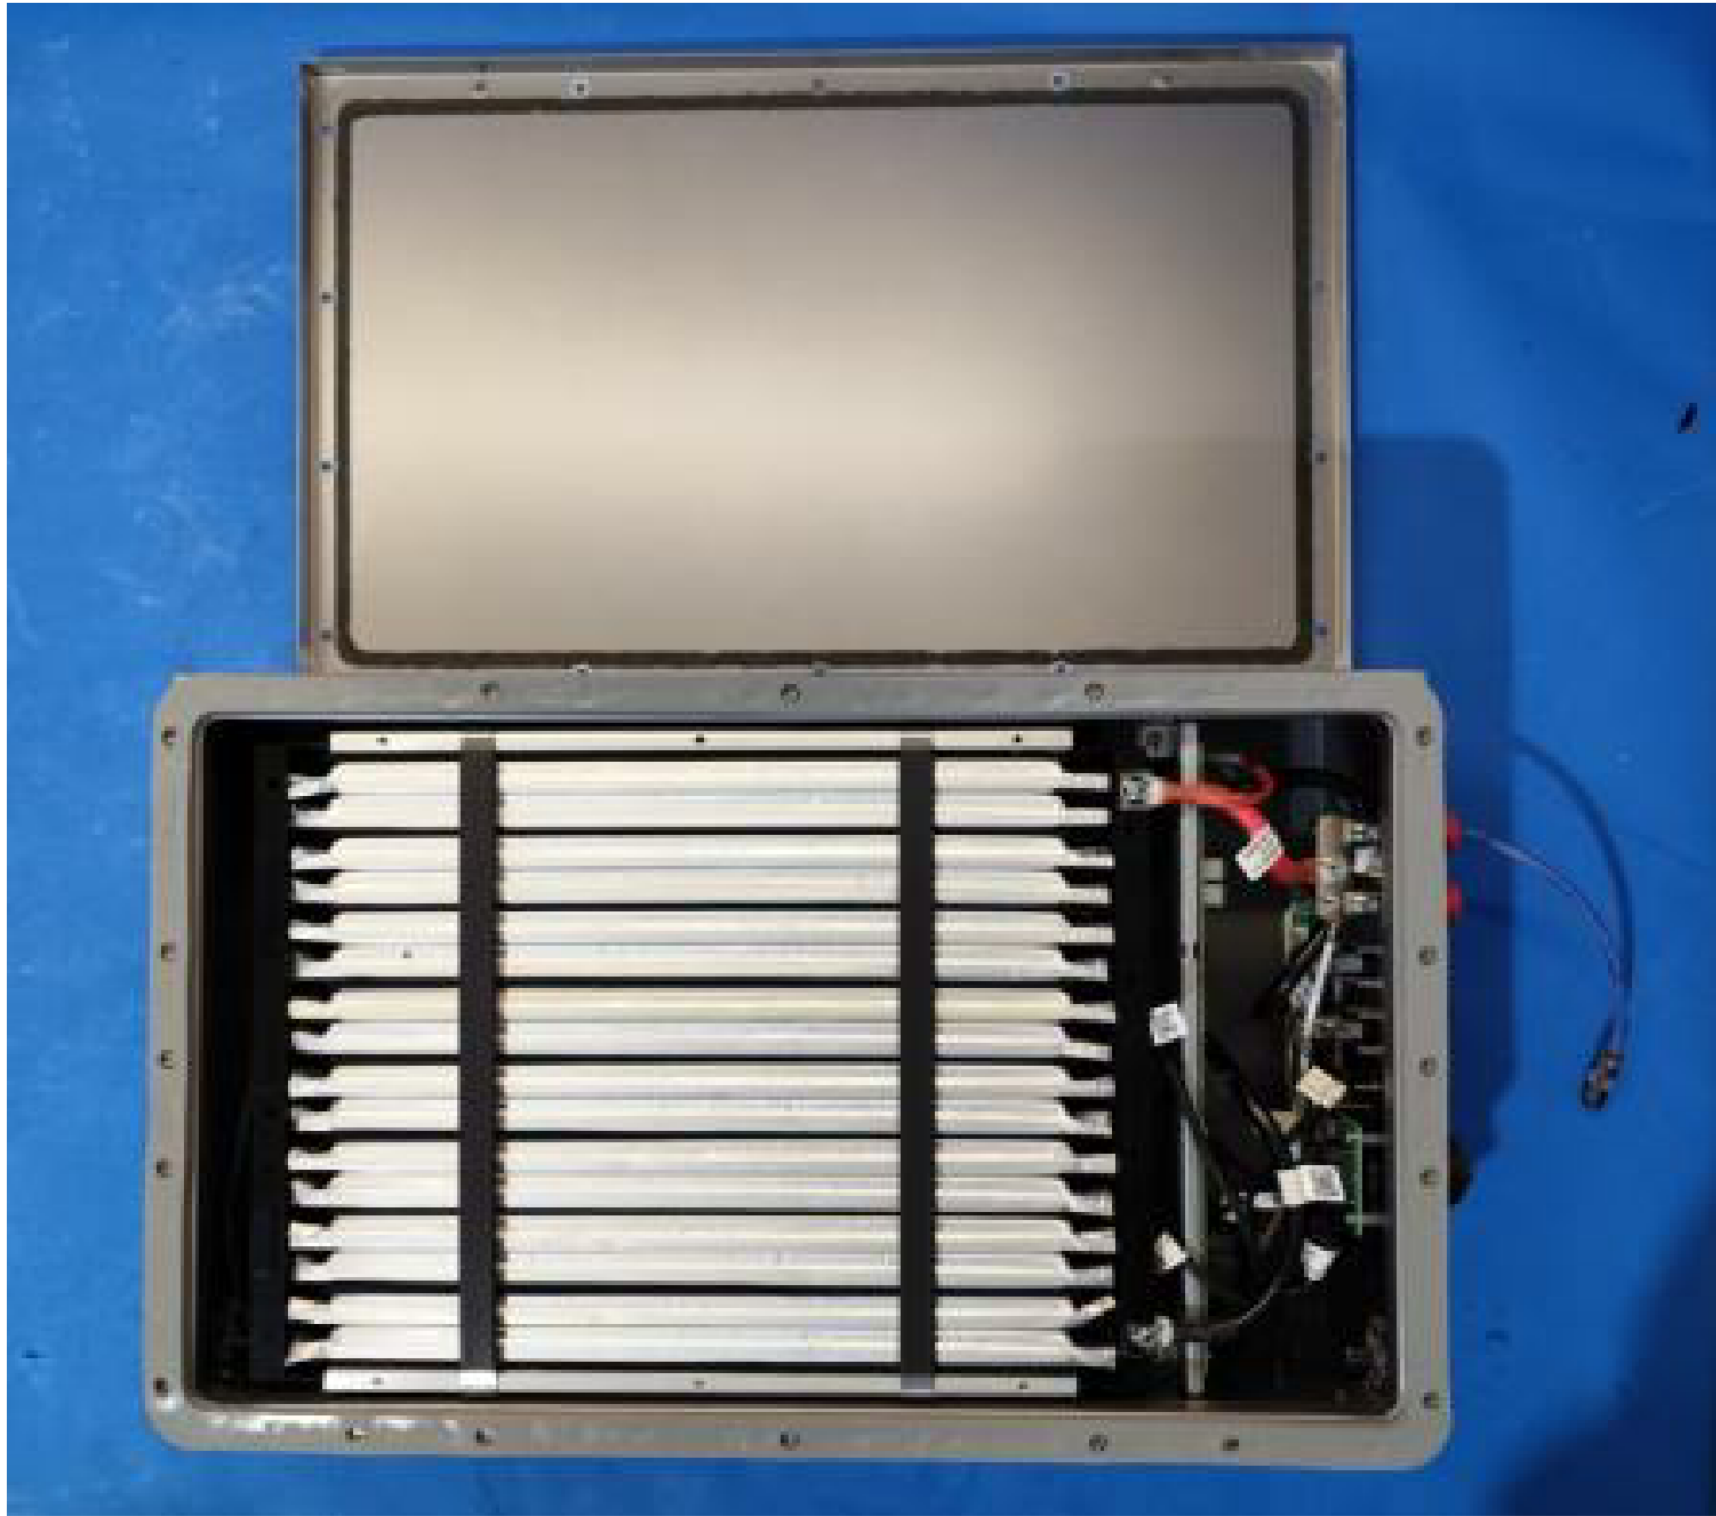
| Fig.R01.5 After the test | Fig.R01.6 After the test no dust inside |

| Test Results | After the test, visual inspection on the sample, no abnormalities on appearance, and open the sample to check, there is no dust inside. Then power on the sample to check that it can start up normally. | | | | |

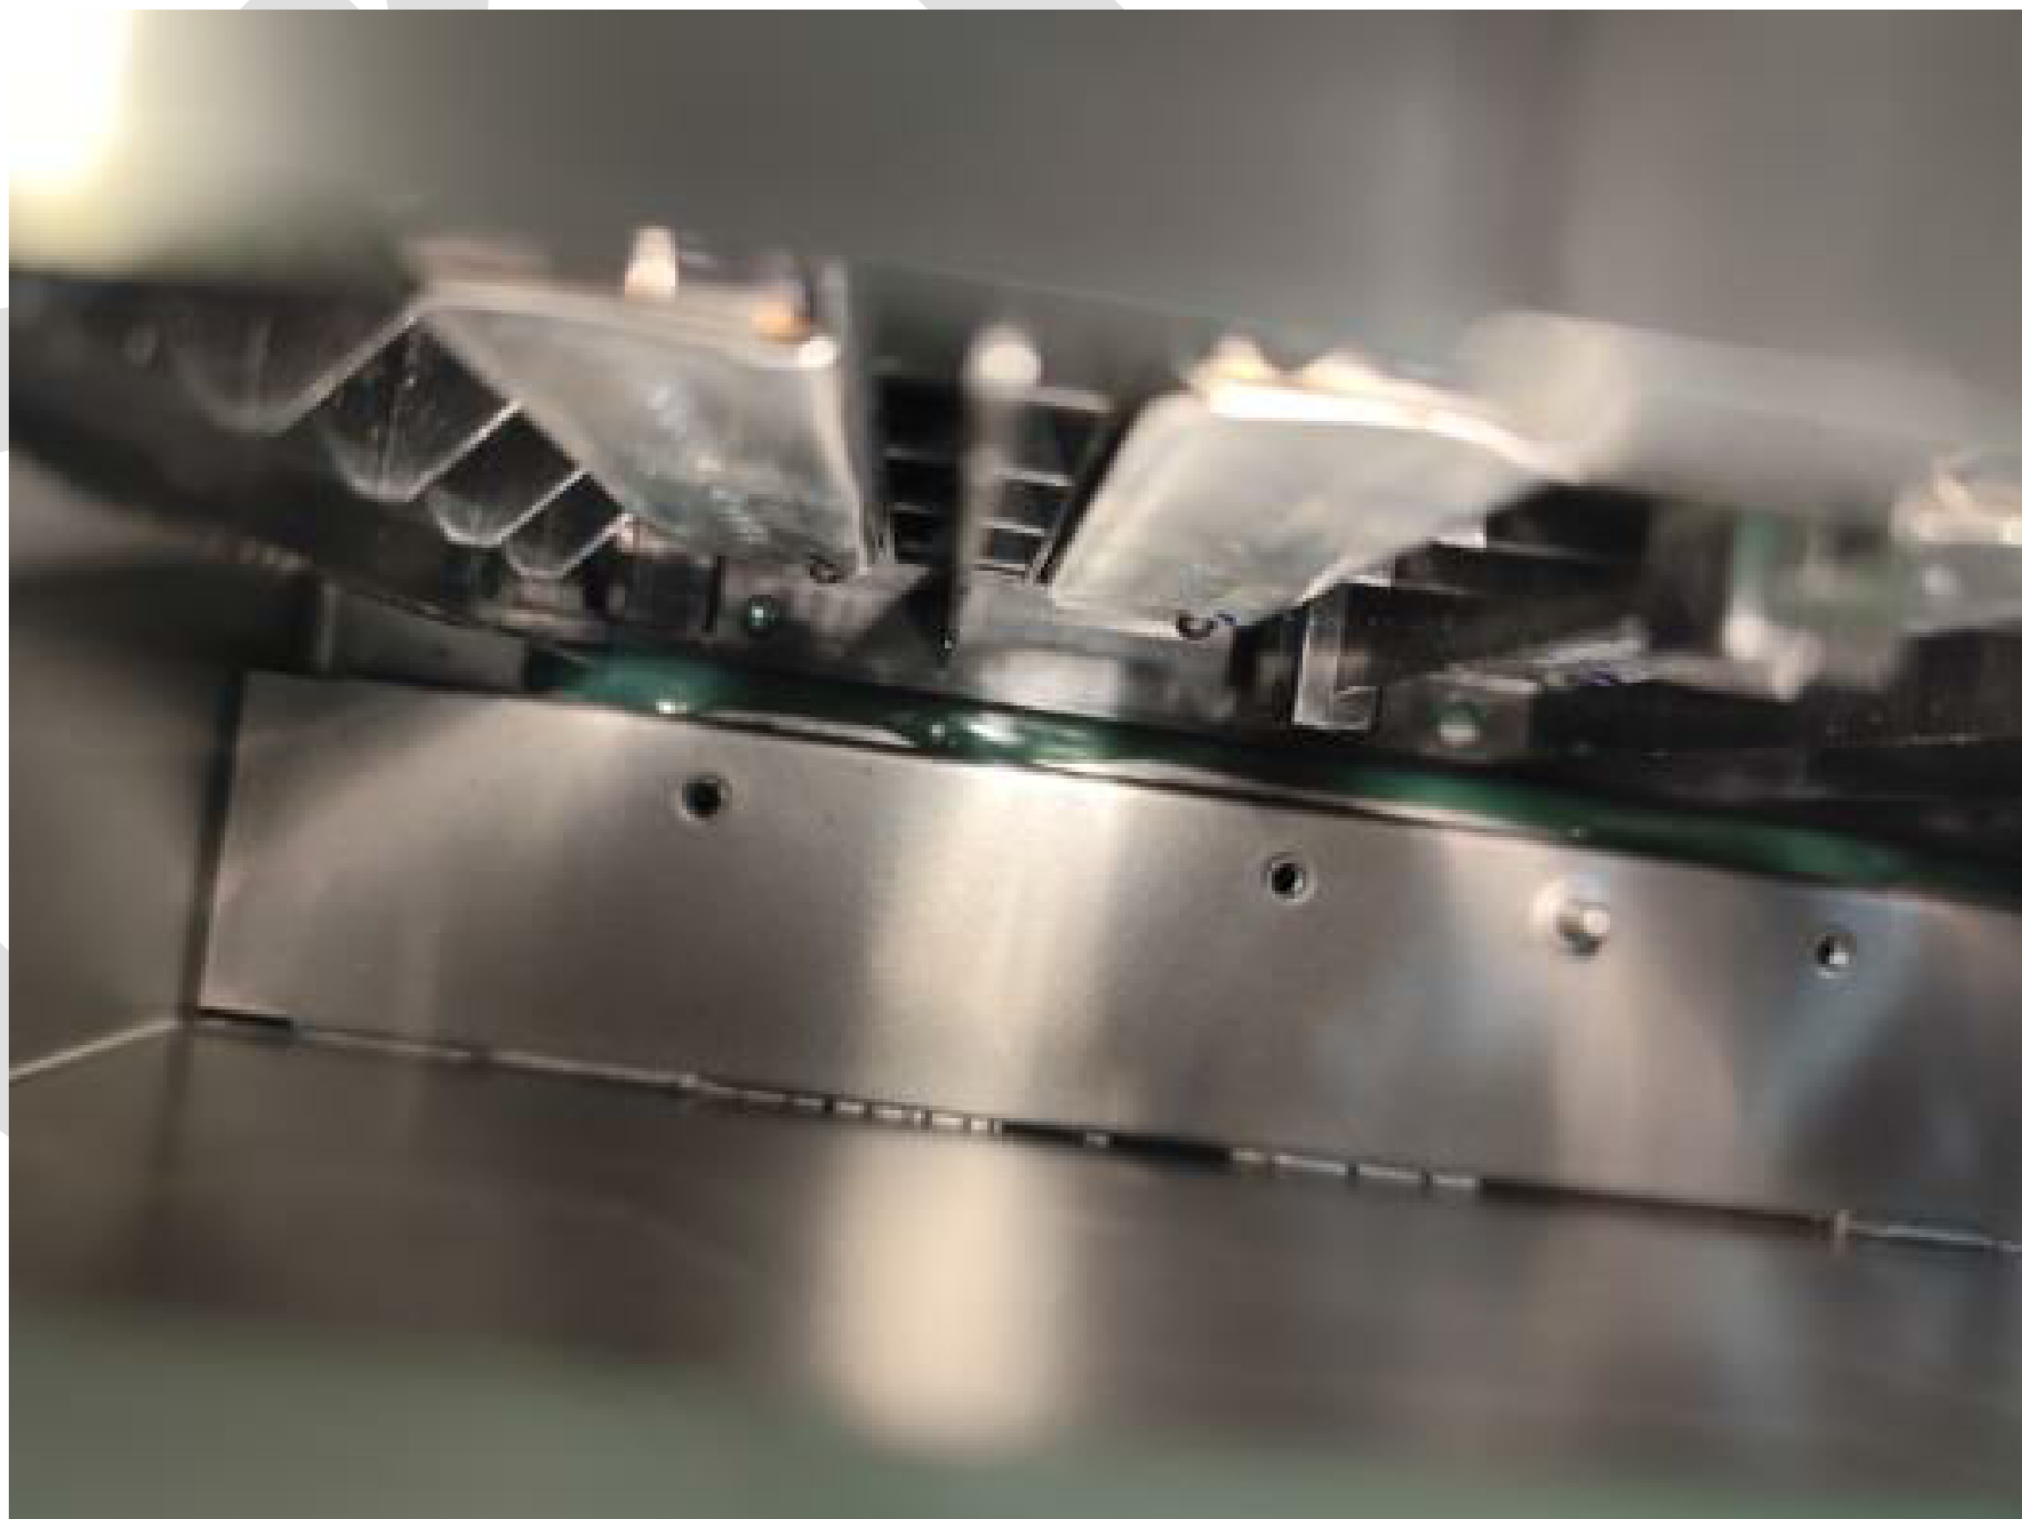
| Fig.R01.7 After the test no dust inside | Fig.R01.8 After the test no dust inside |
