# TEST REPORT

Sample Name : Battery protection module

Sample Model : FB-L-5.12-EU

Report No.: CJ2509150R01E

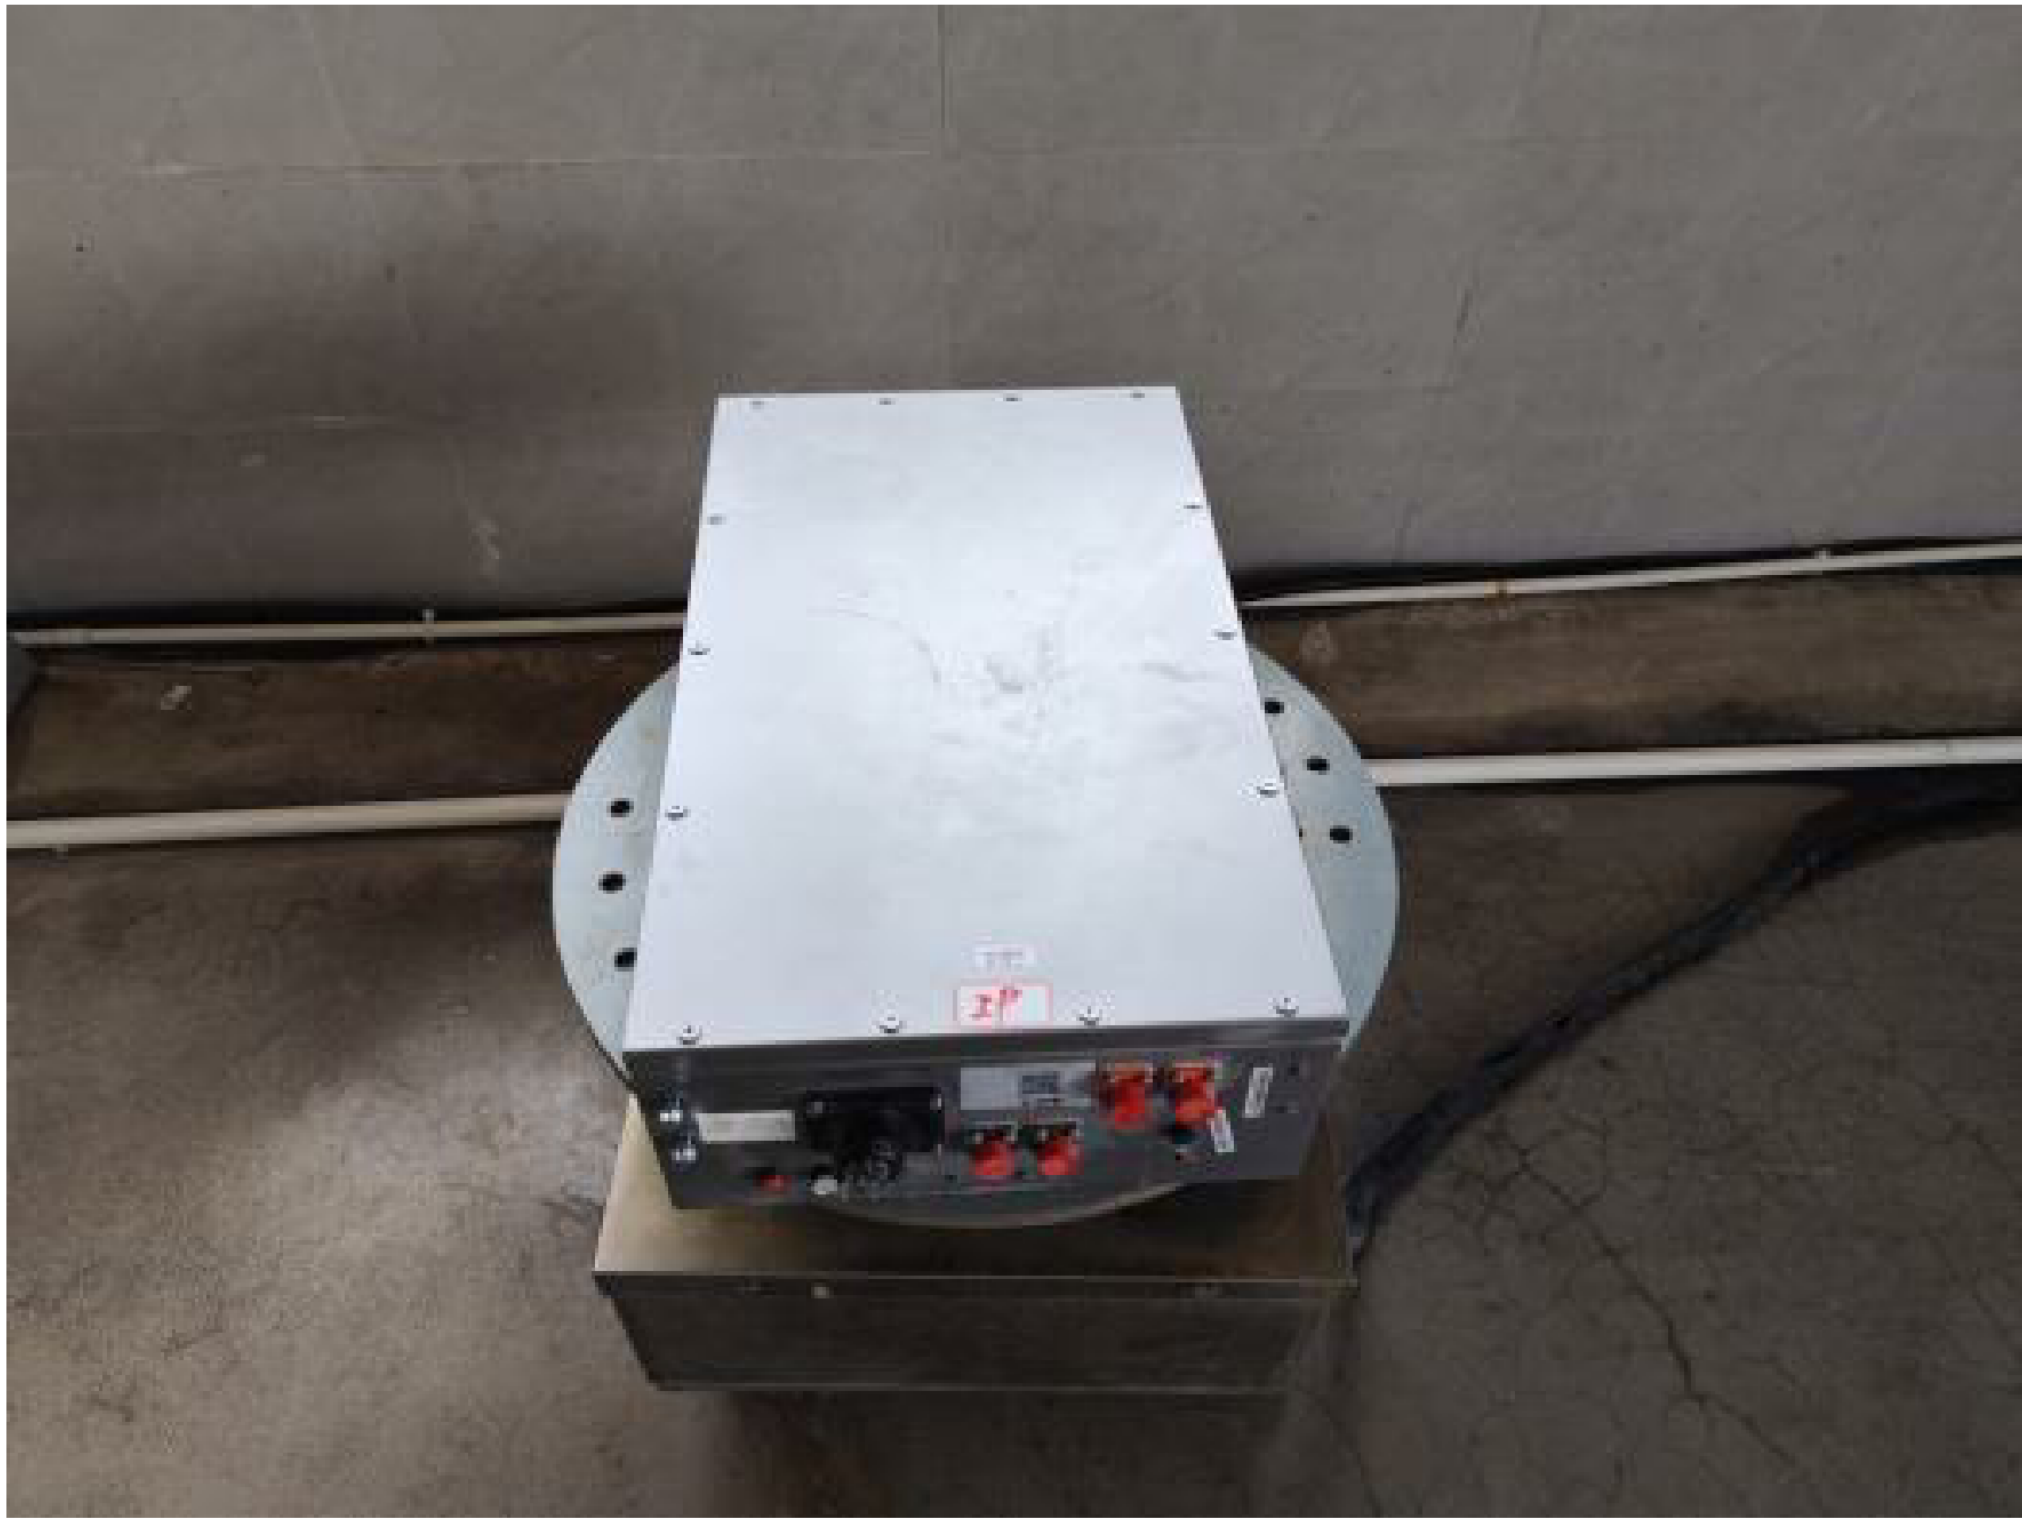
Fig.R02.1 During the test setup

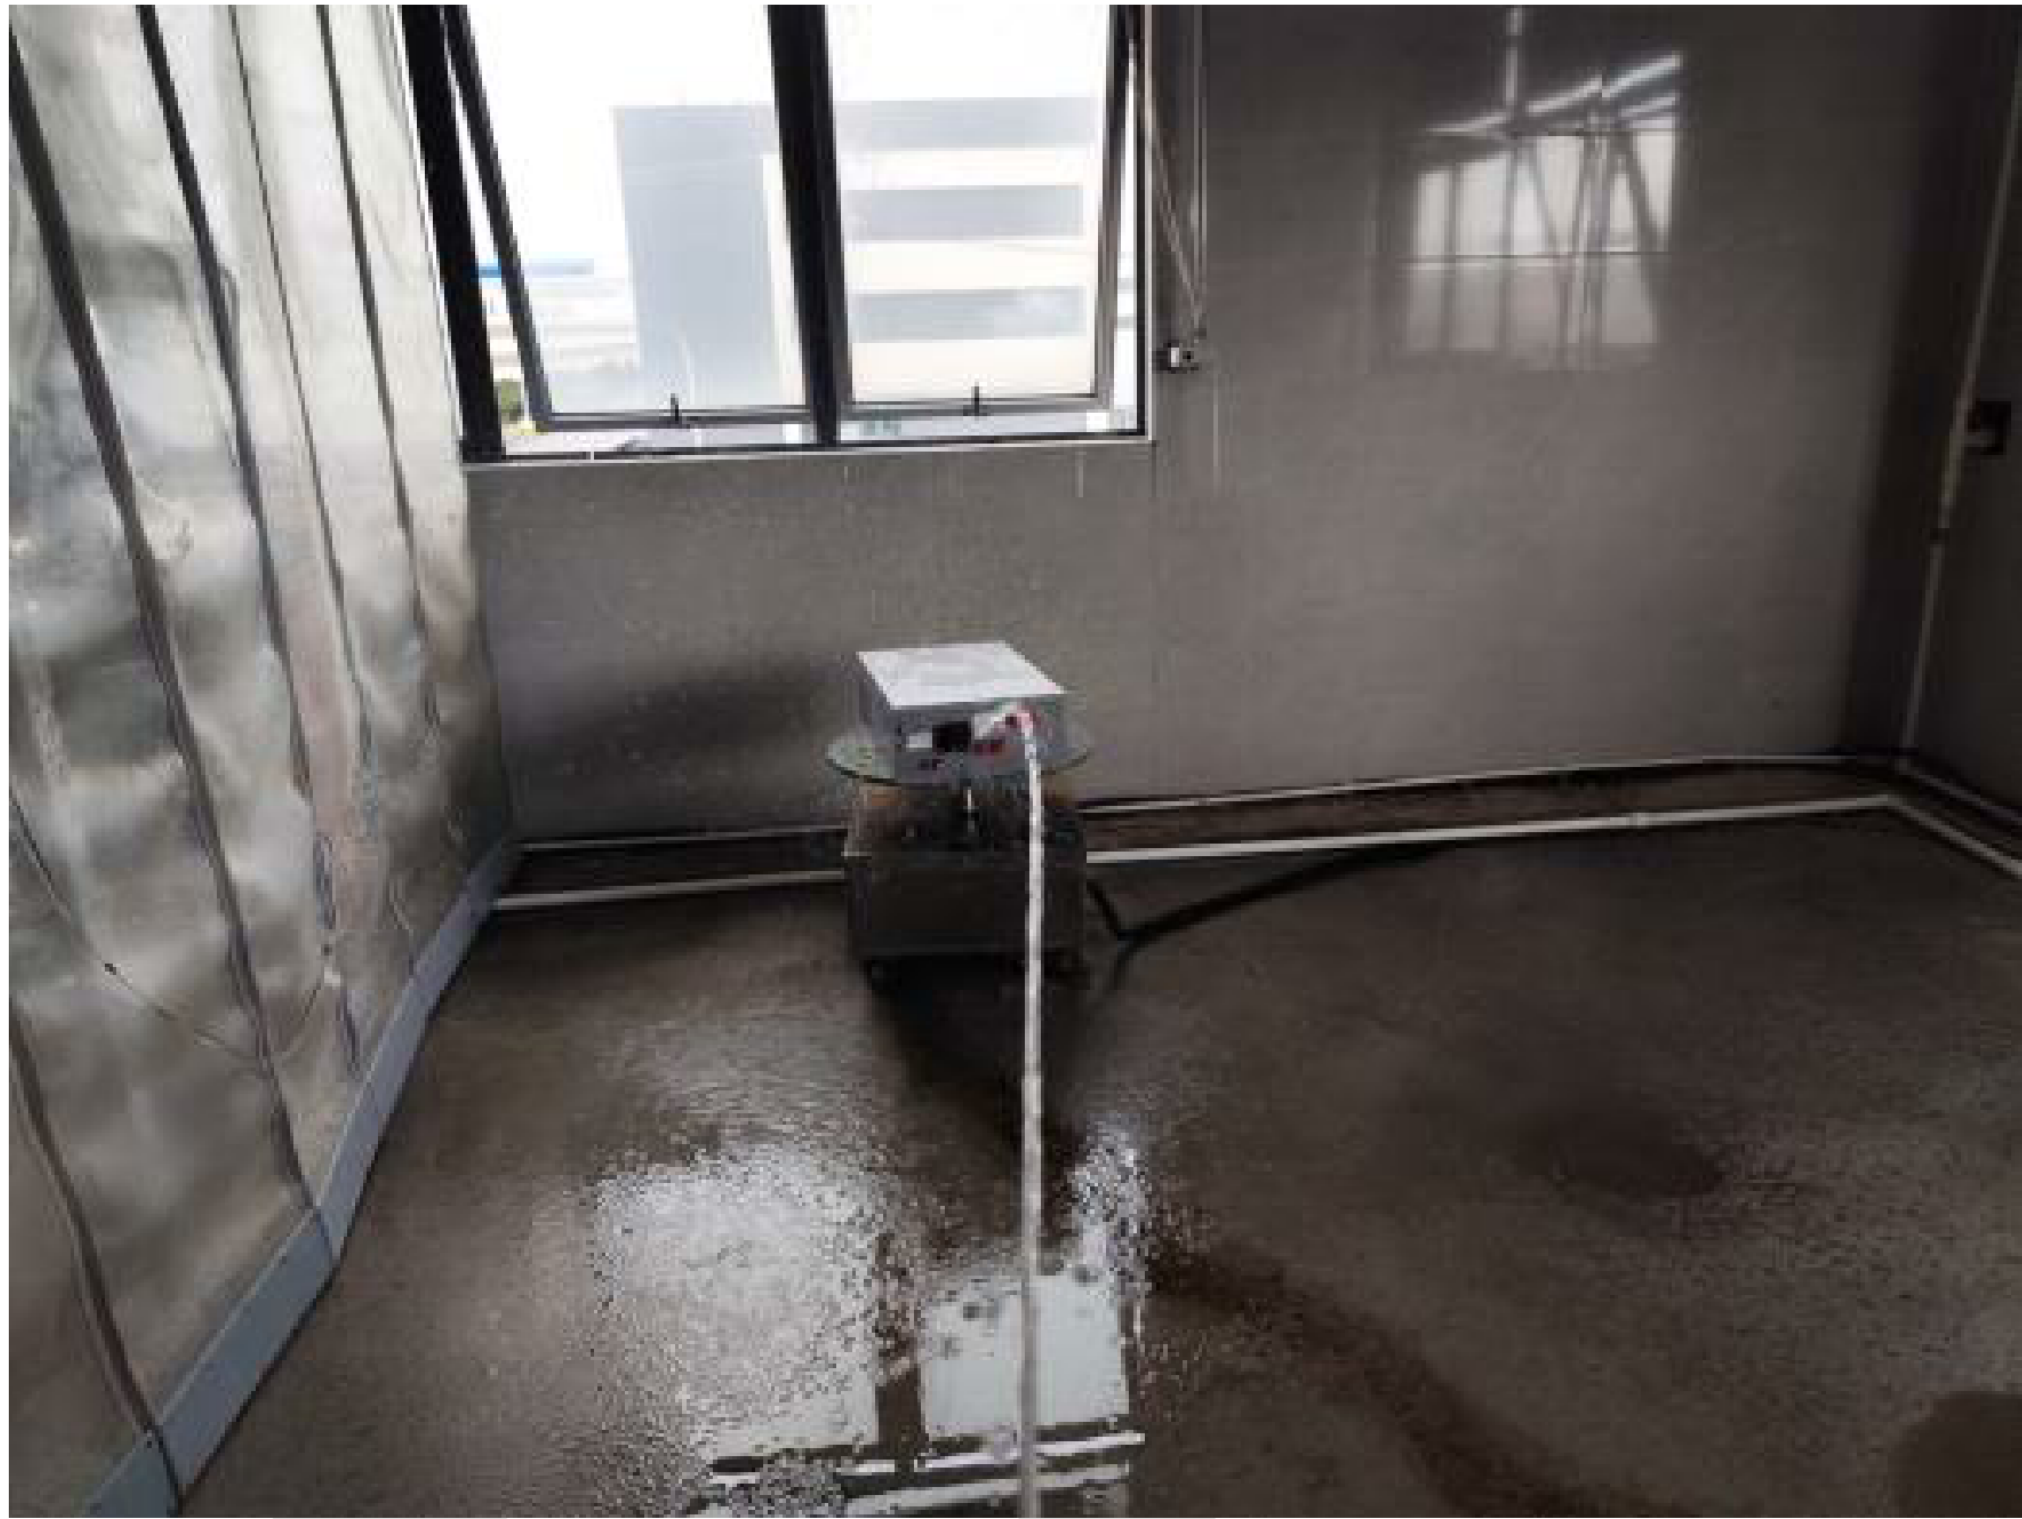
Fig.R02.2 During the test

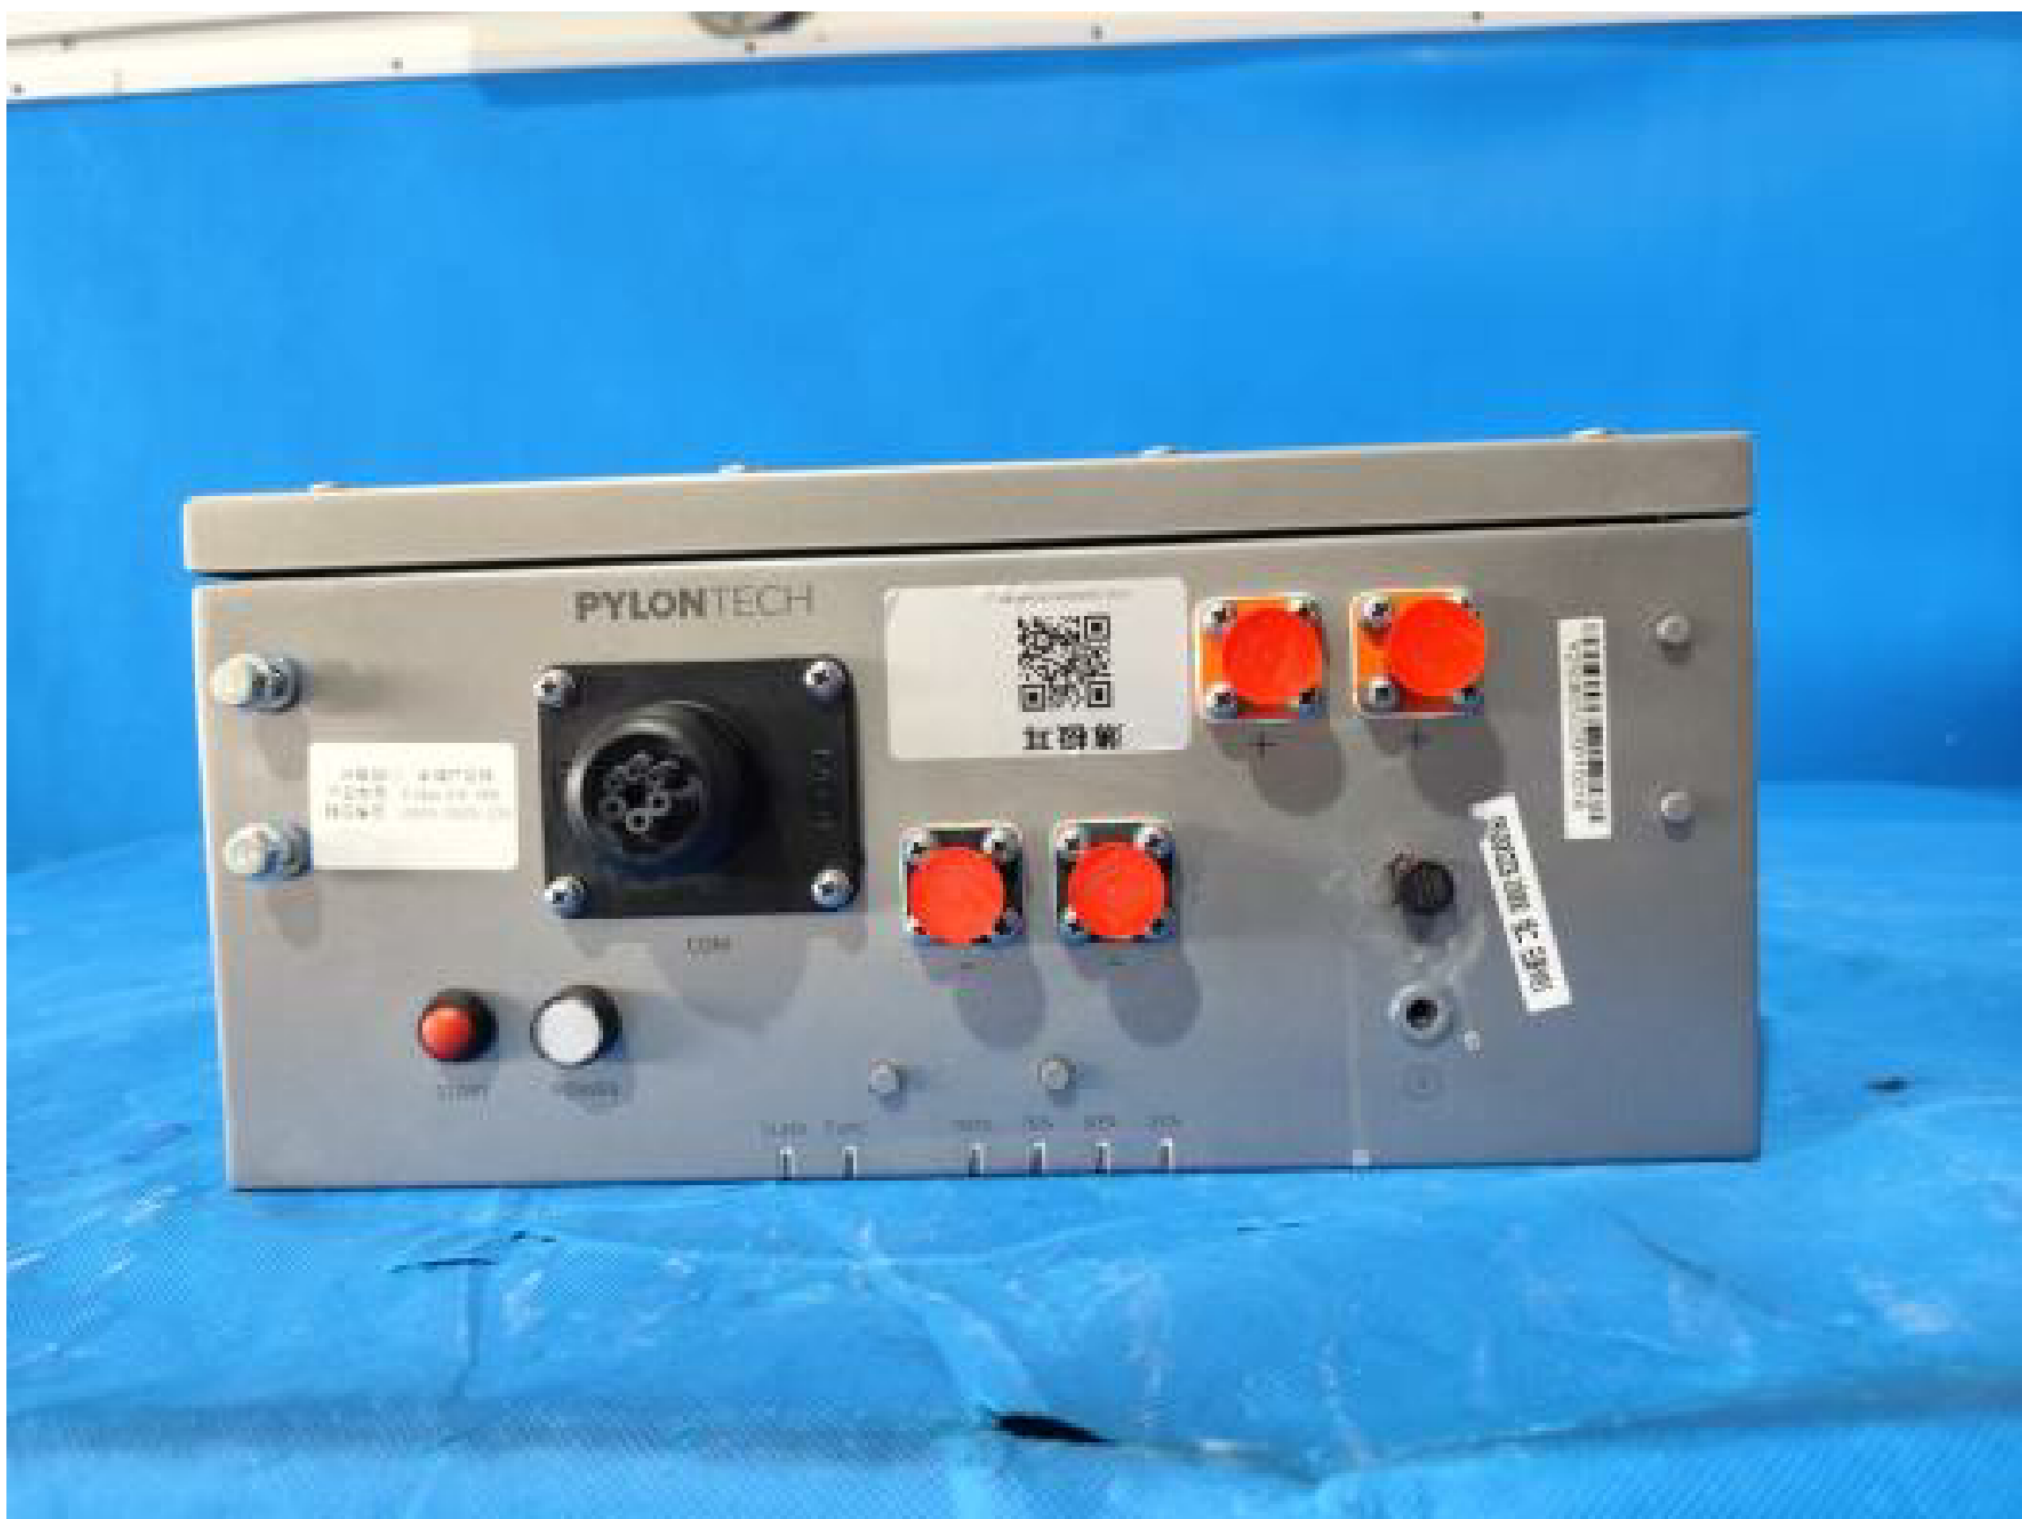
Fig.R02.3 After the test

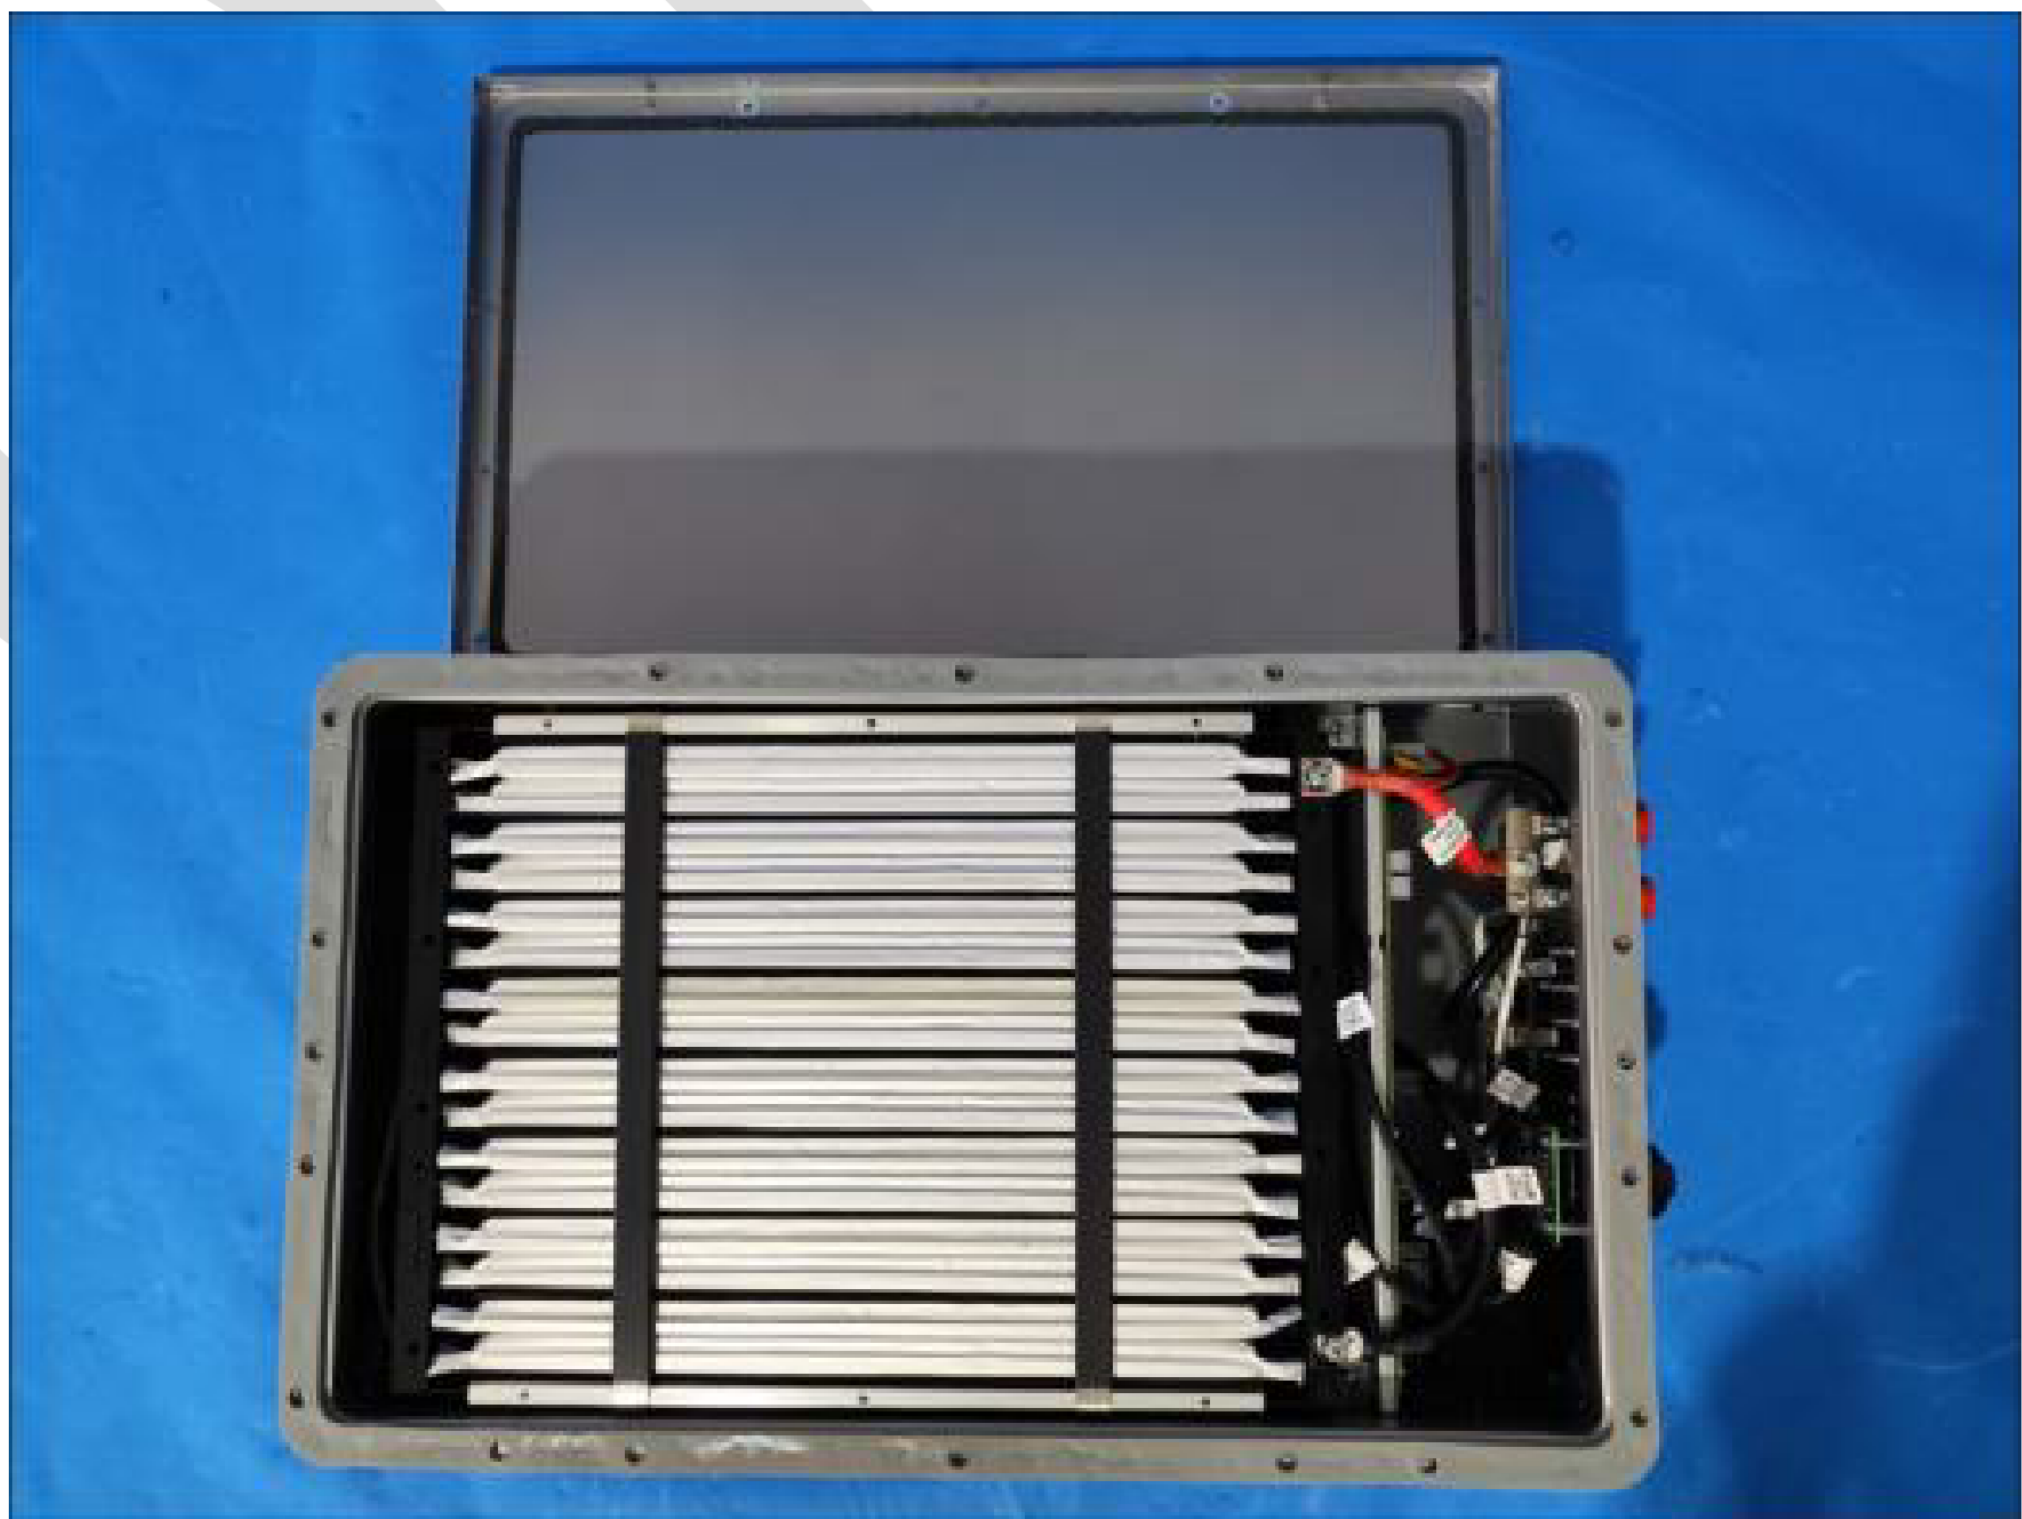
Fig.R02.4 After the test no water inside

| Test Results | <p>After the test, visual inspection on the sample, no abnormalities on appearance, and open the sample to check, there is no water inside. Then power on the sample to check that it can start up normally.</p> <p>No breakdown or flashover occurs during the withstand voltage test.</p> <p>Leakage current is 6 μA, meet the requirements.</p> | | | | |

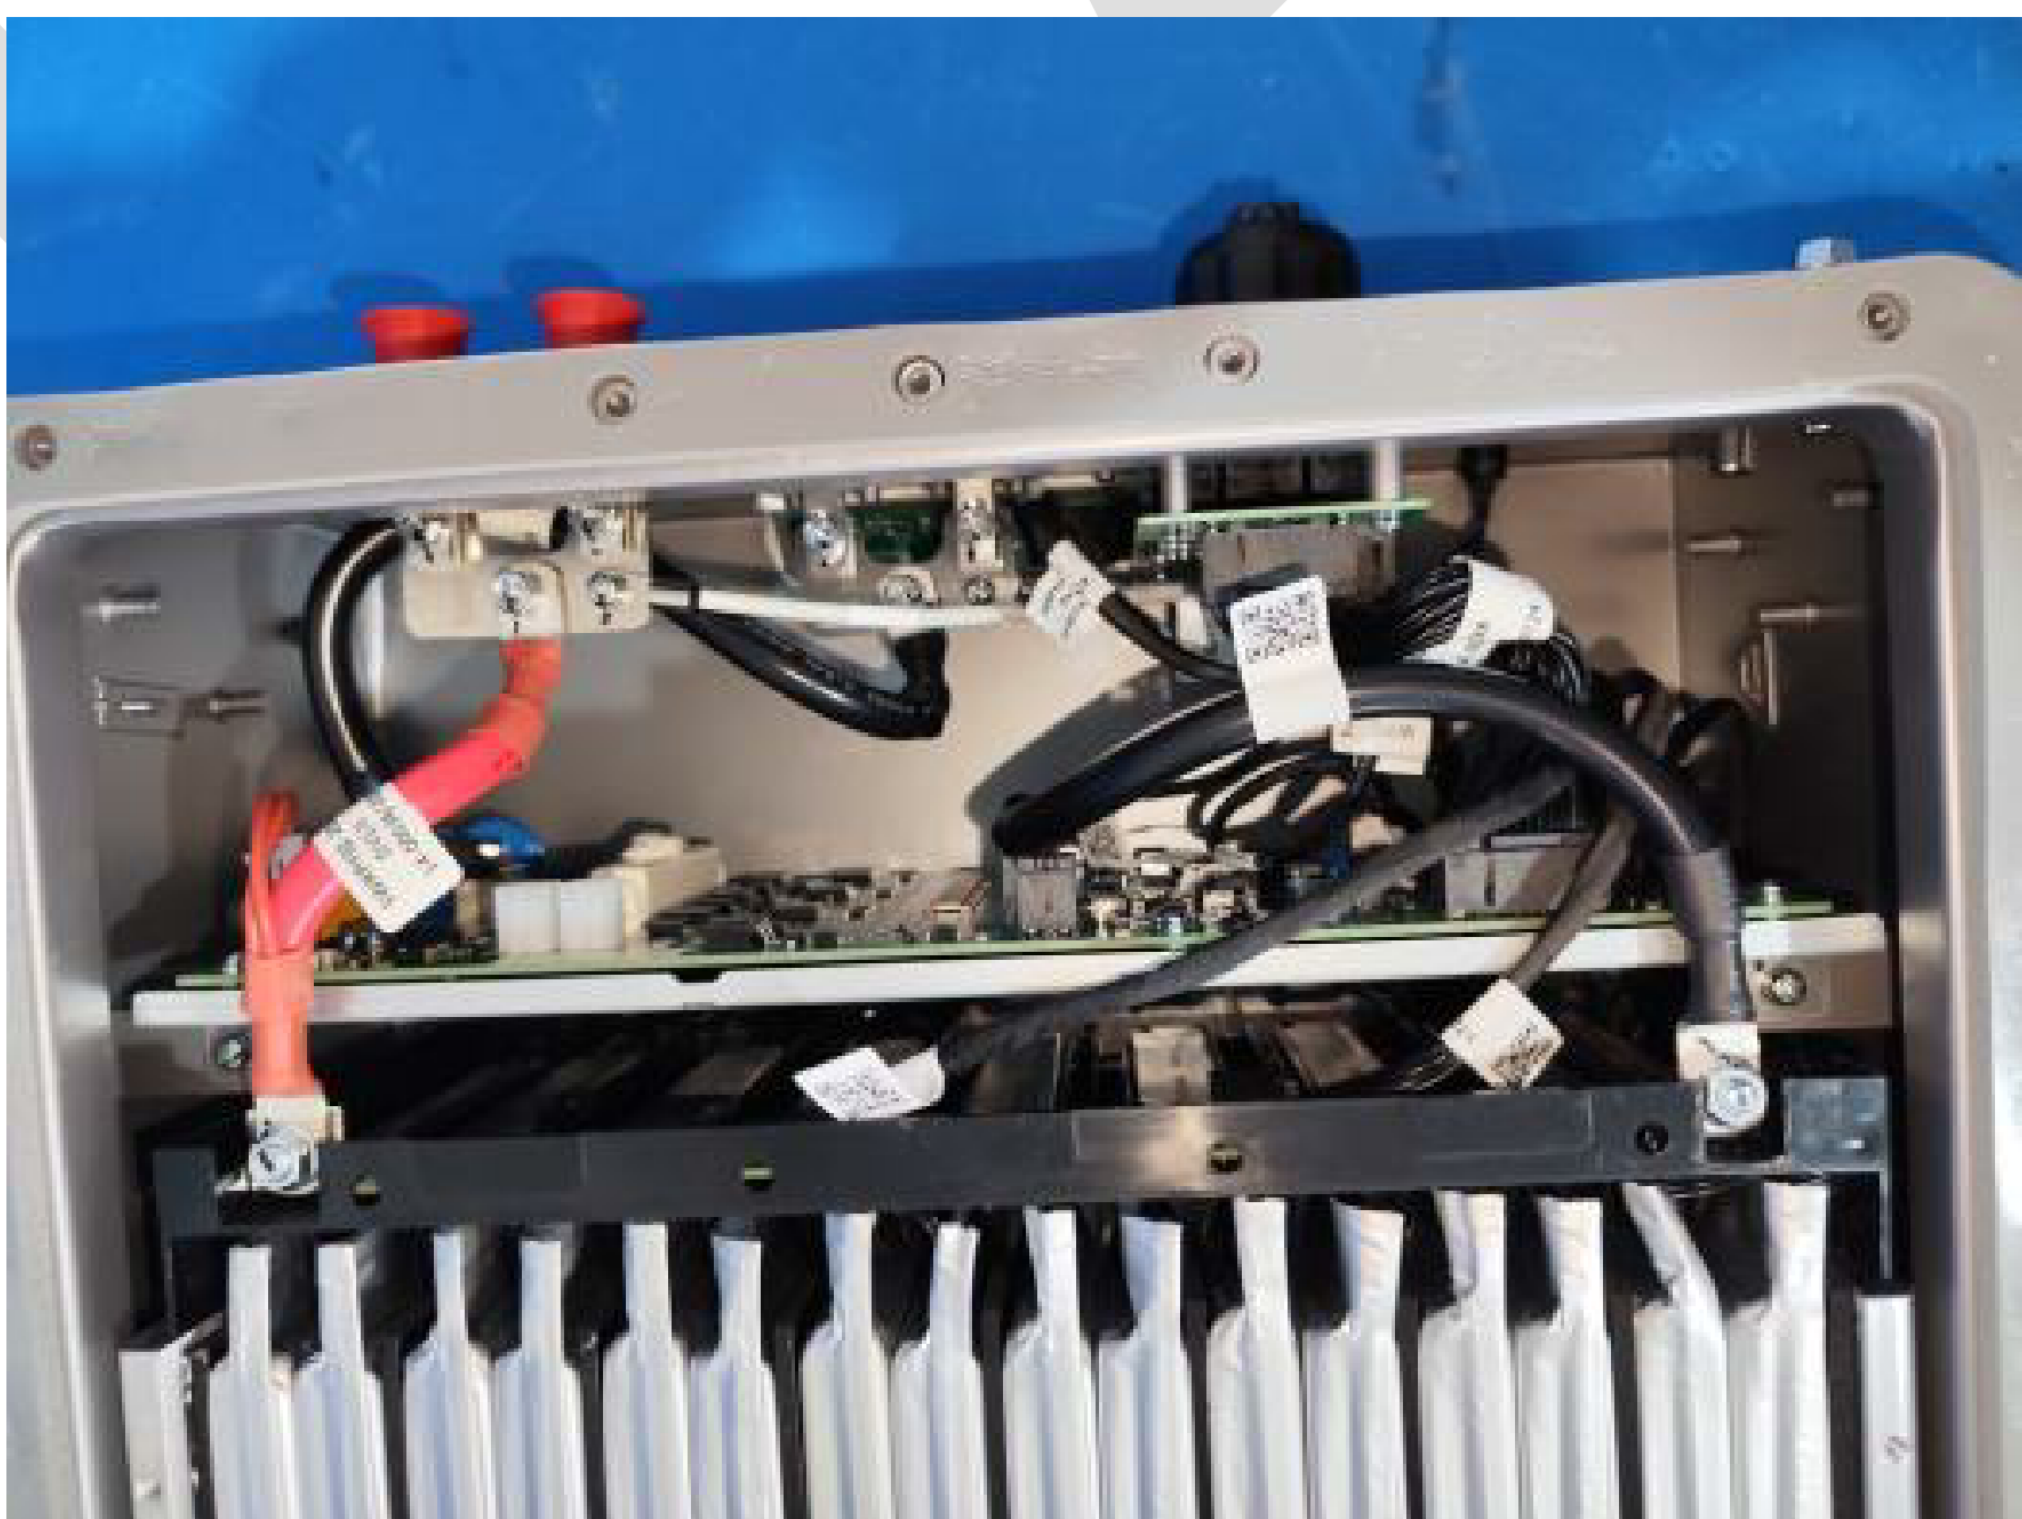
Fig.R02.5 After the test no water inside

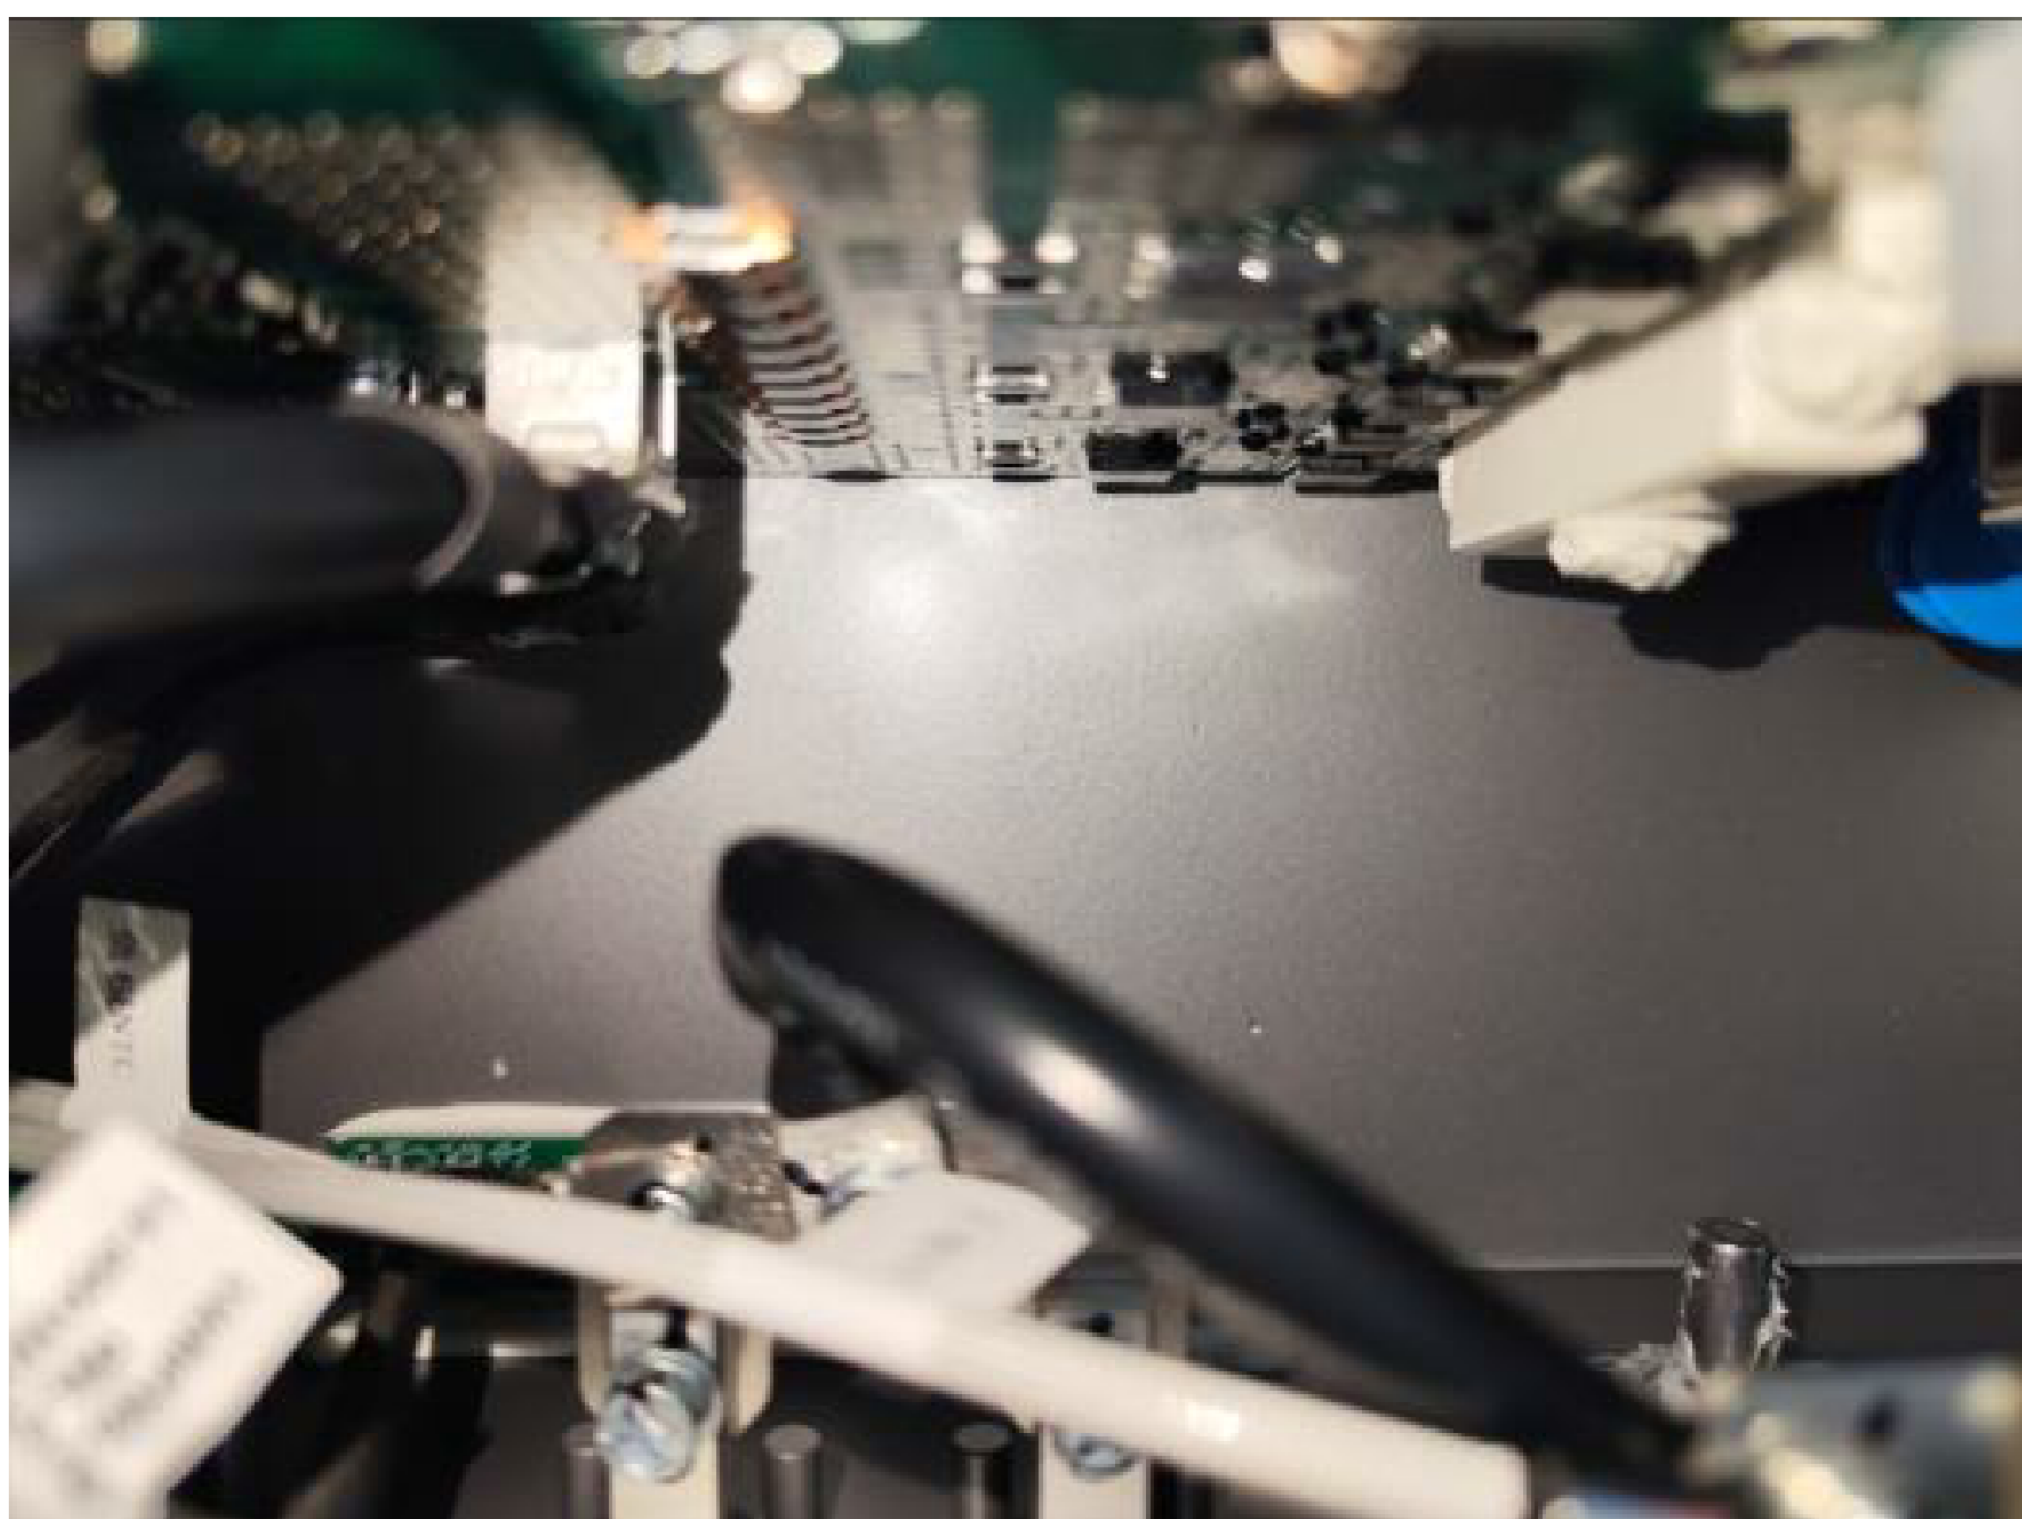
Fig.R02.6 After the test no water inside

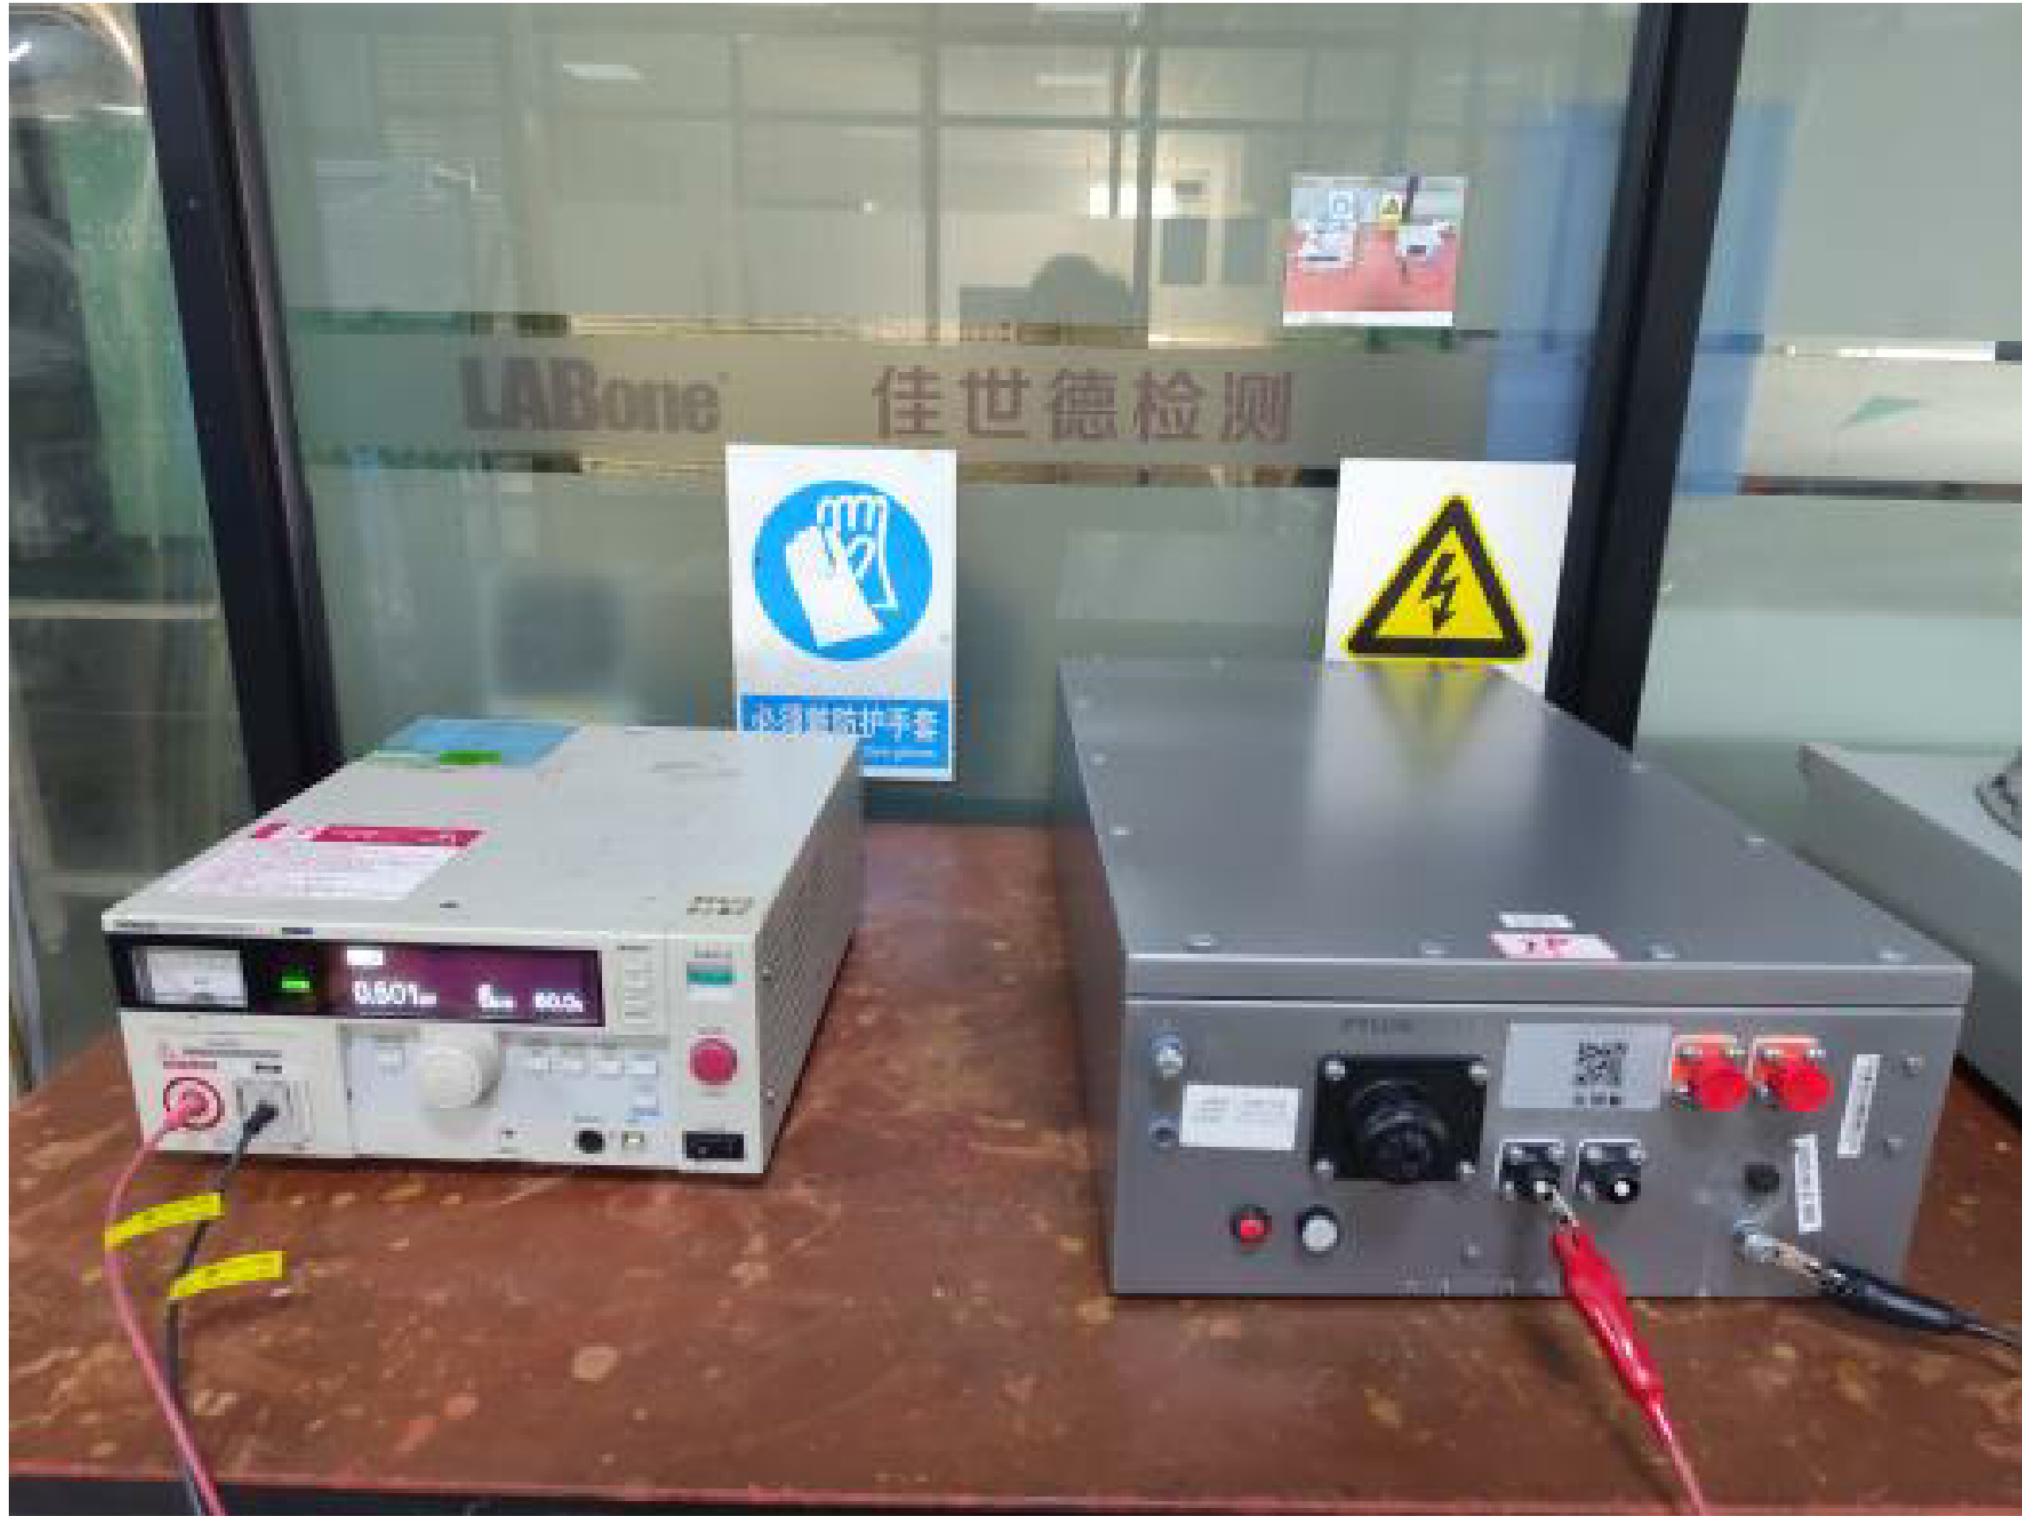
| <p>Fig.R02.7    After the test<br/>The sample can start up normally.</p> | <p>Fig.R02.8    After the test<br/>Leakage current is 6 <math>\mu</math>A.</p> |
