# TEST REPORT

Sample Name : Battery protection module

Sample Model : FB-L-5.12-EU

Report No.: CJ2509150R01E

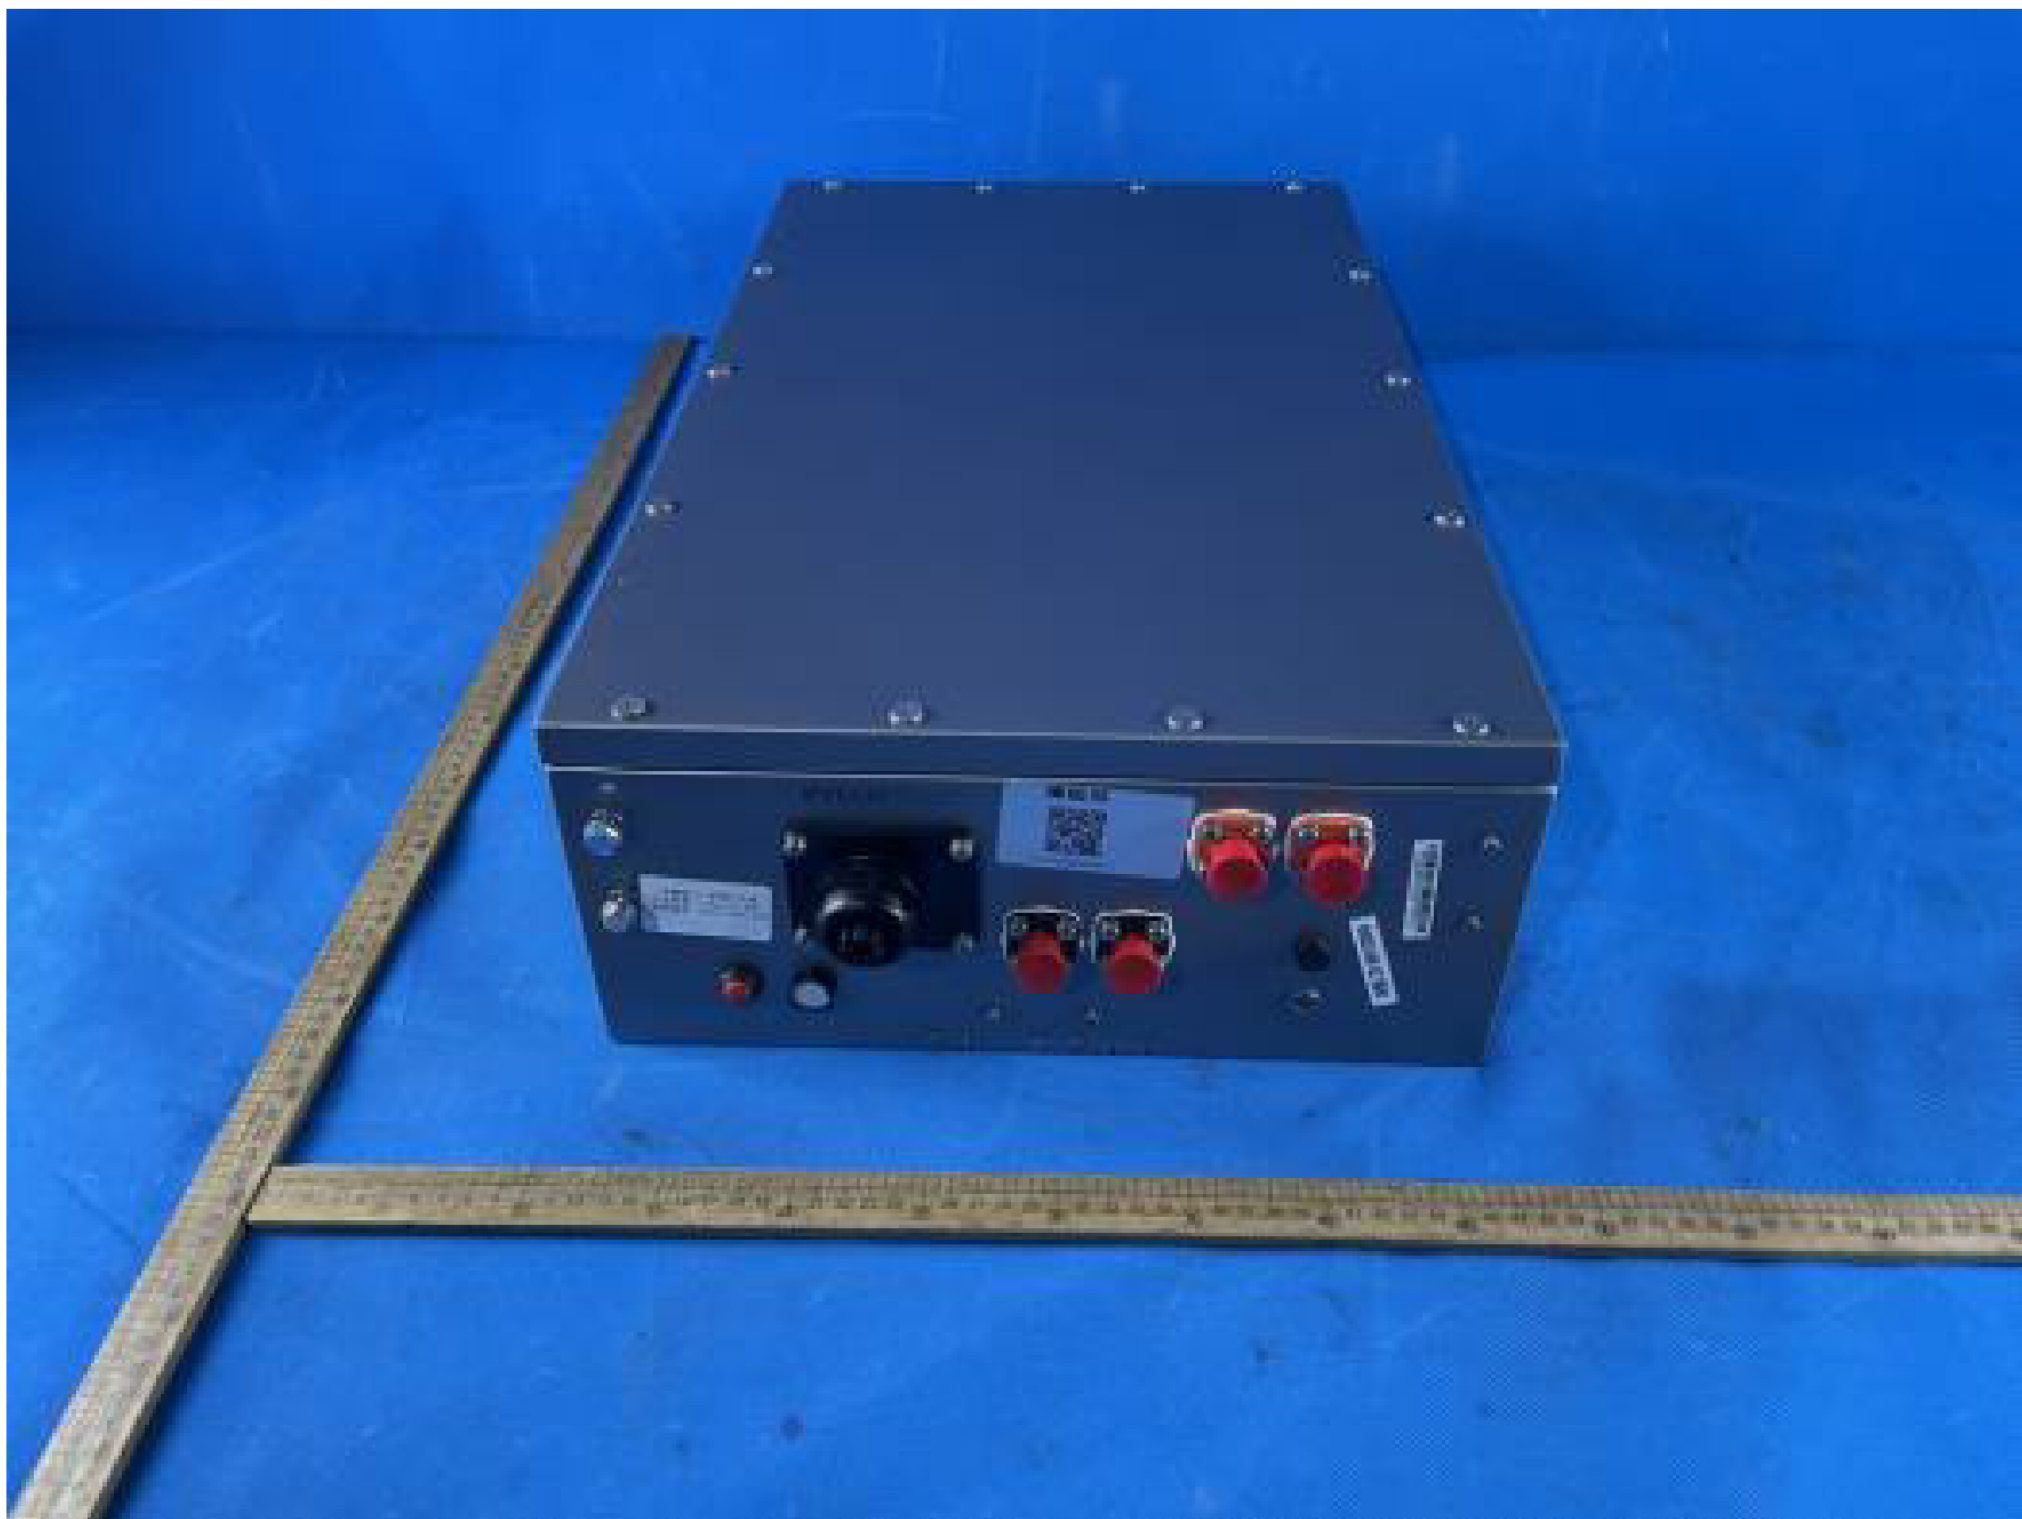
Fig.R03.1 Before the test

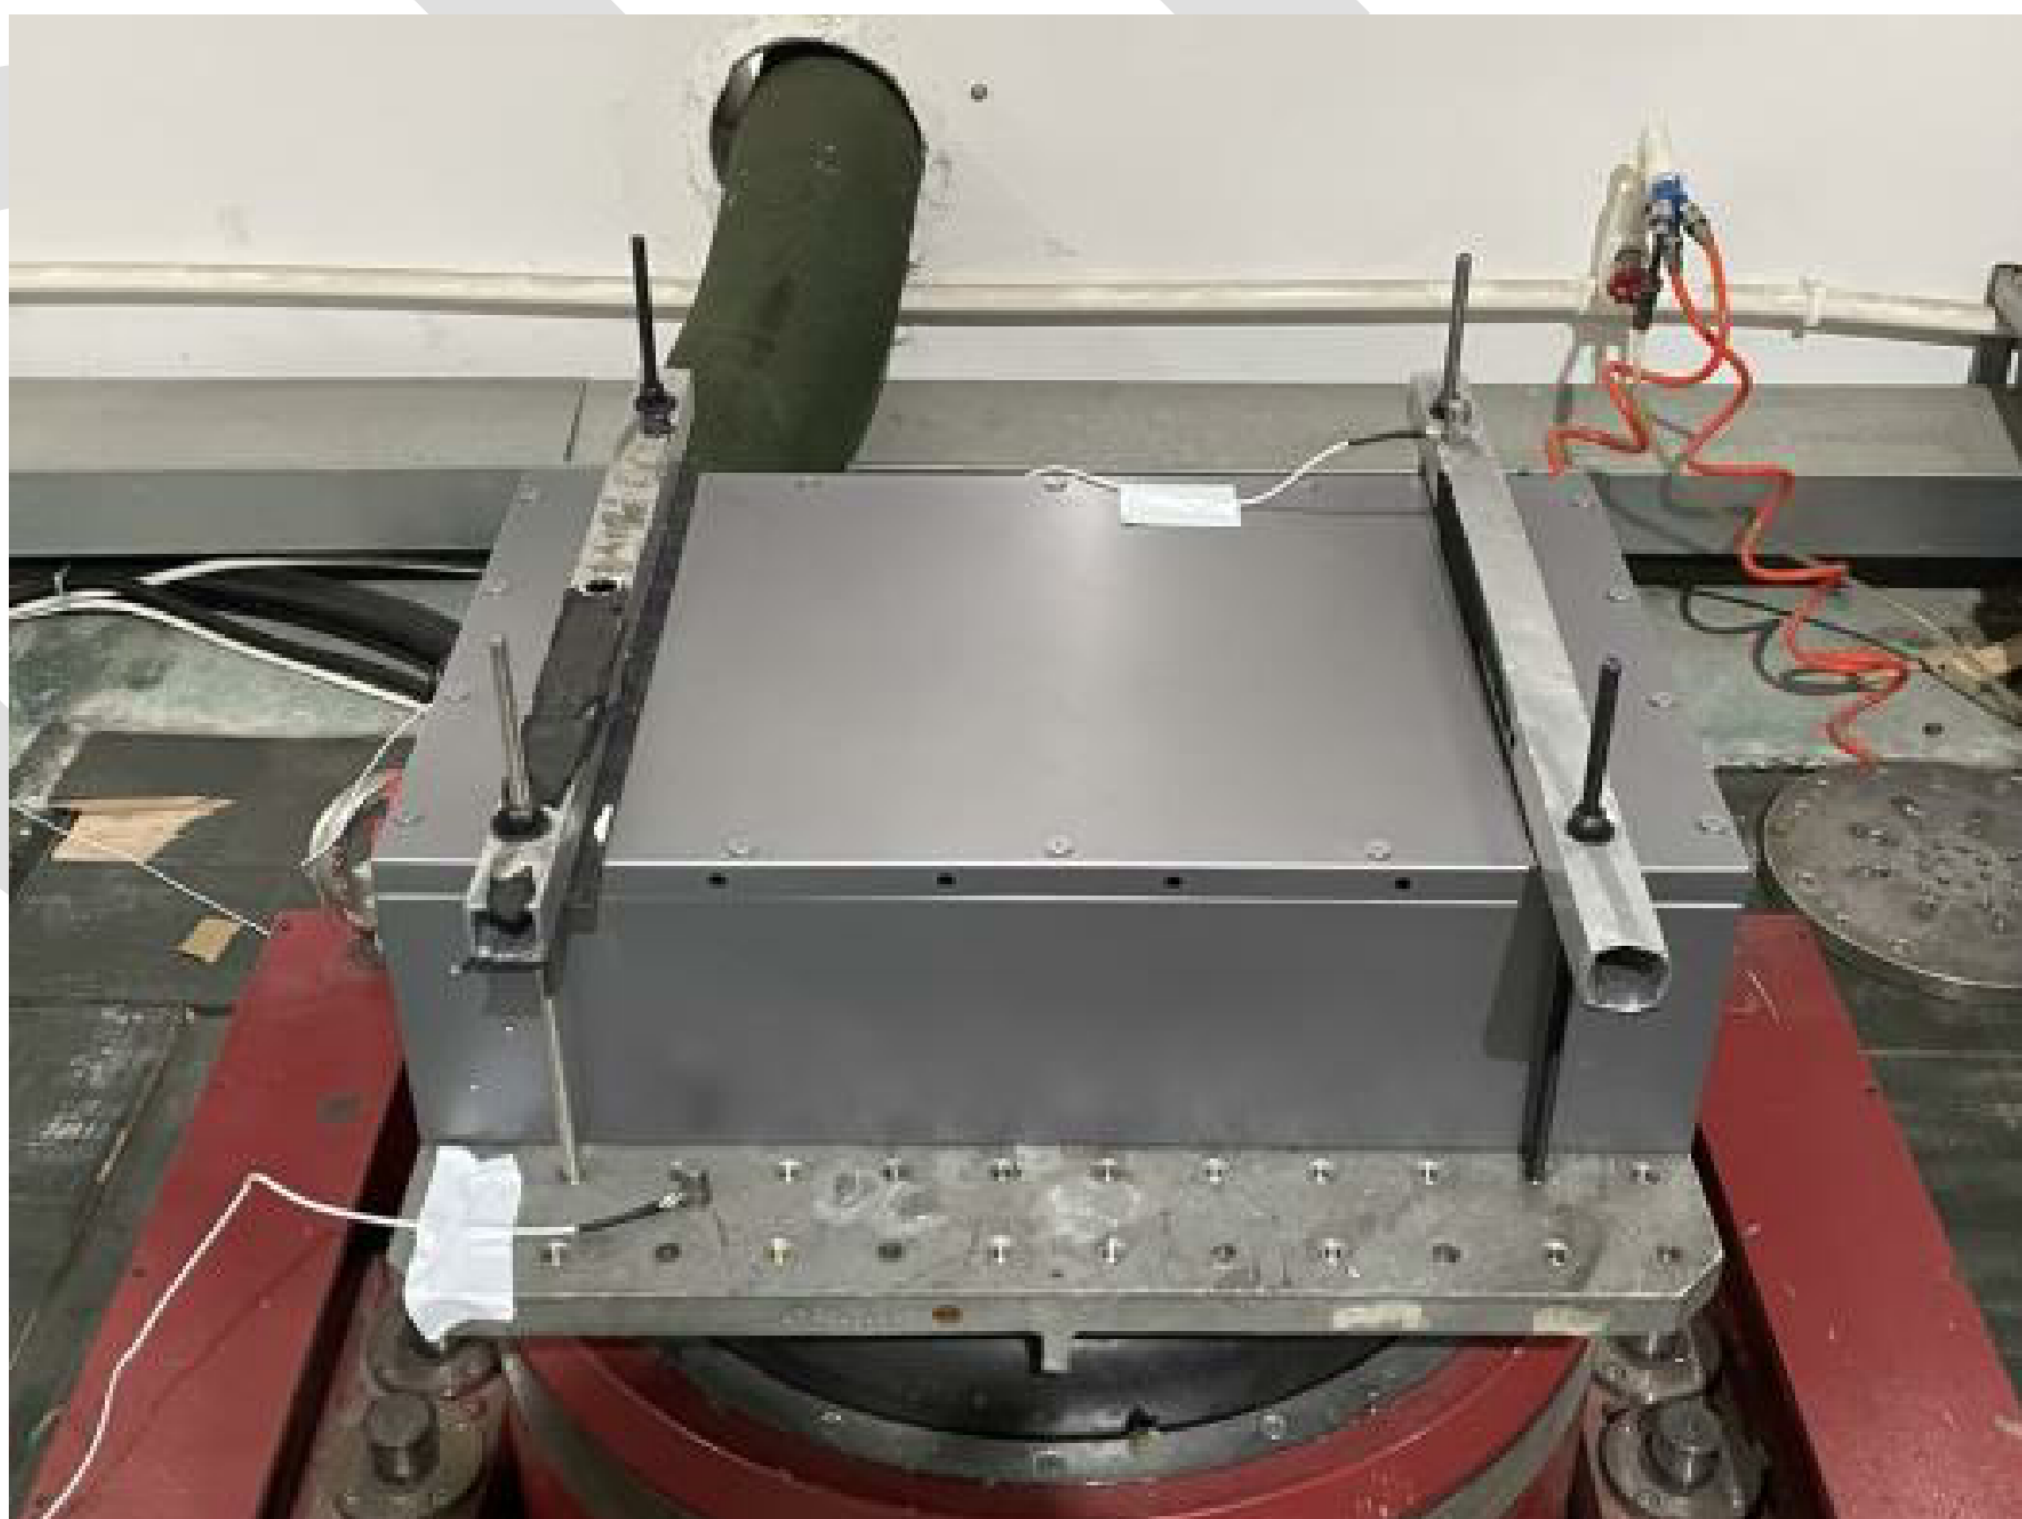
Fig.R03.4 Z axis

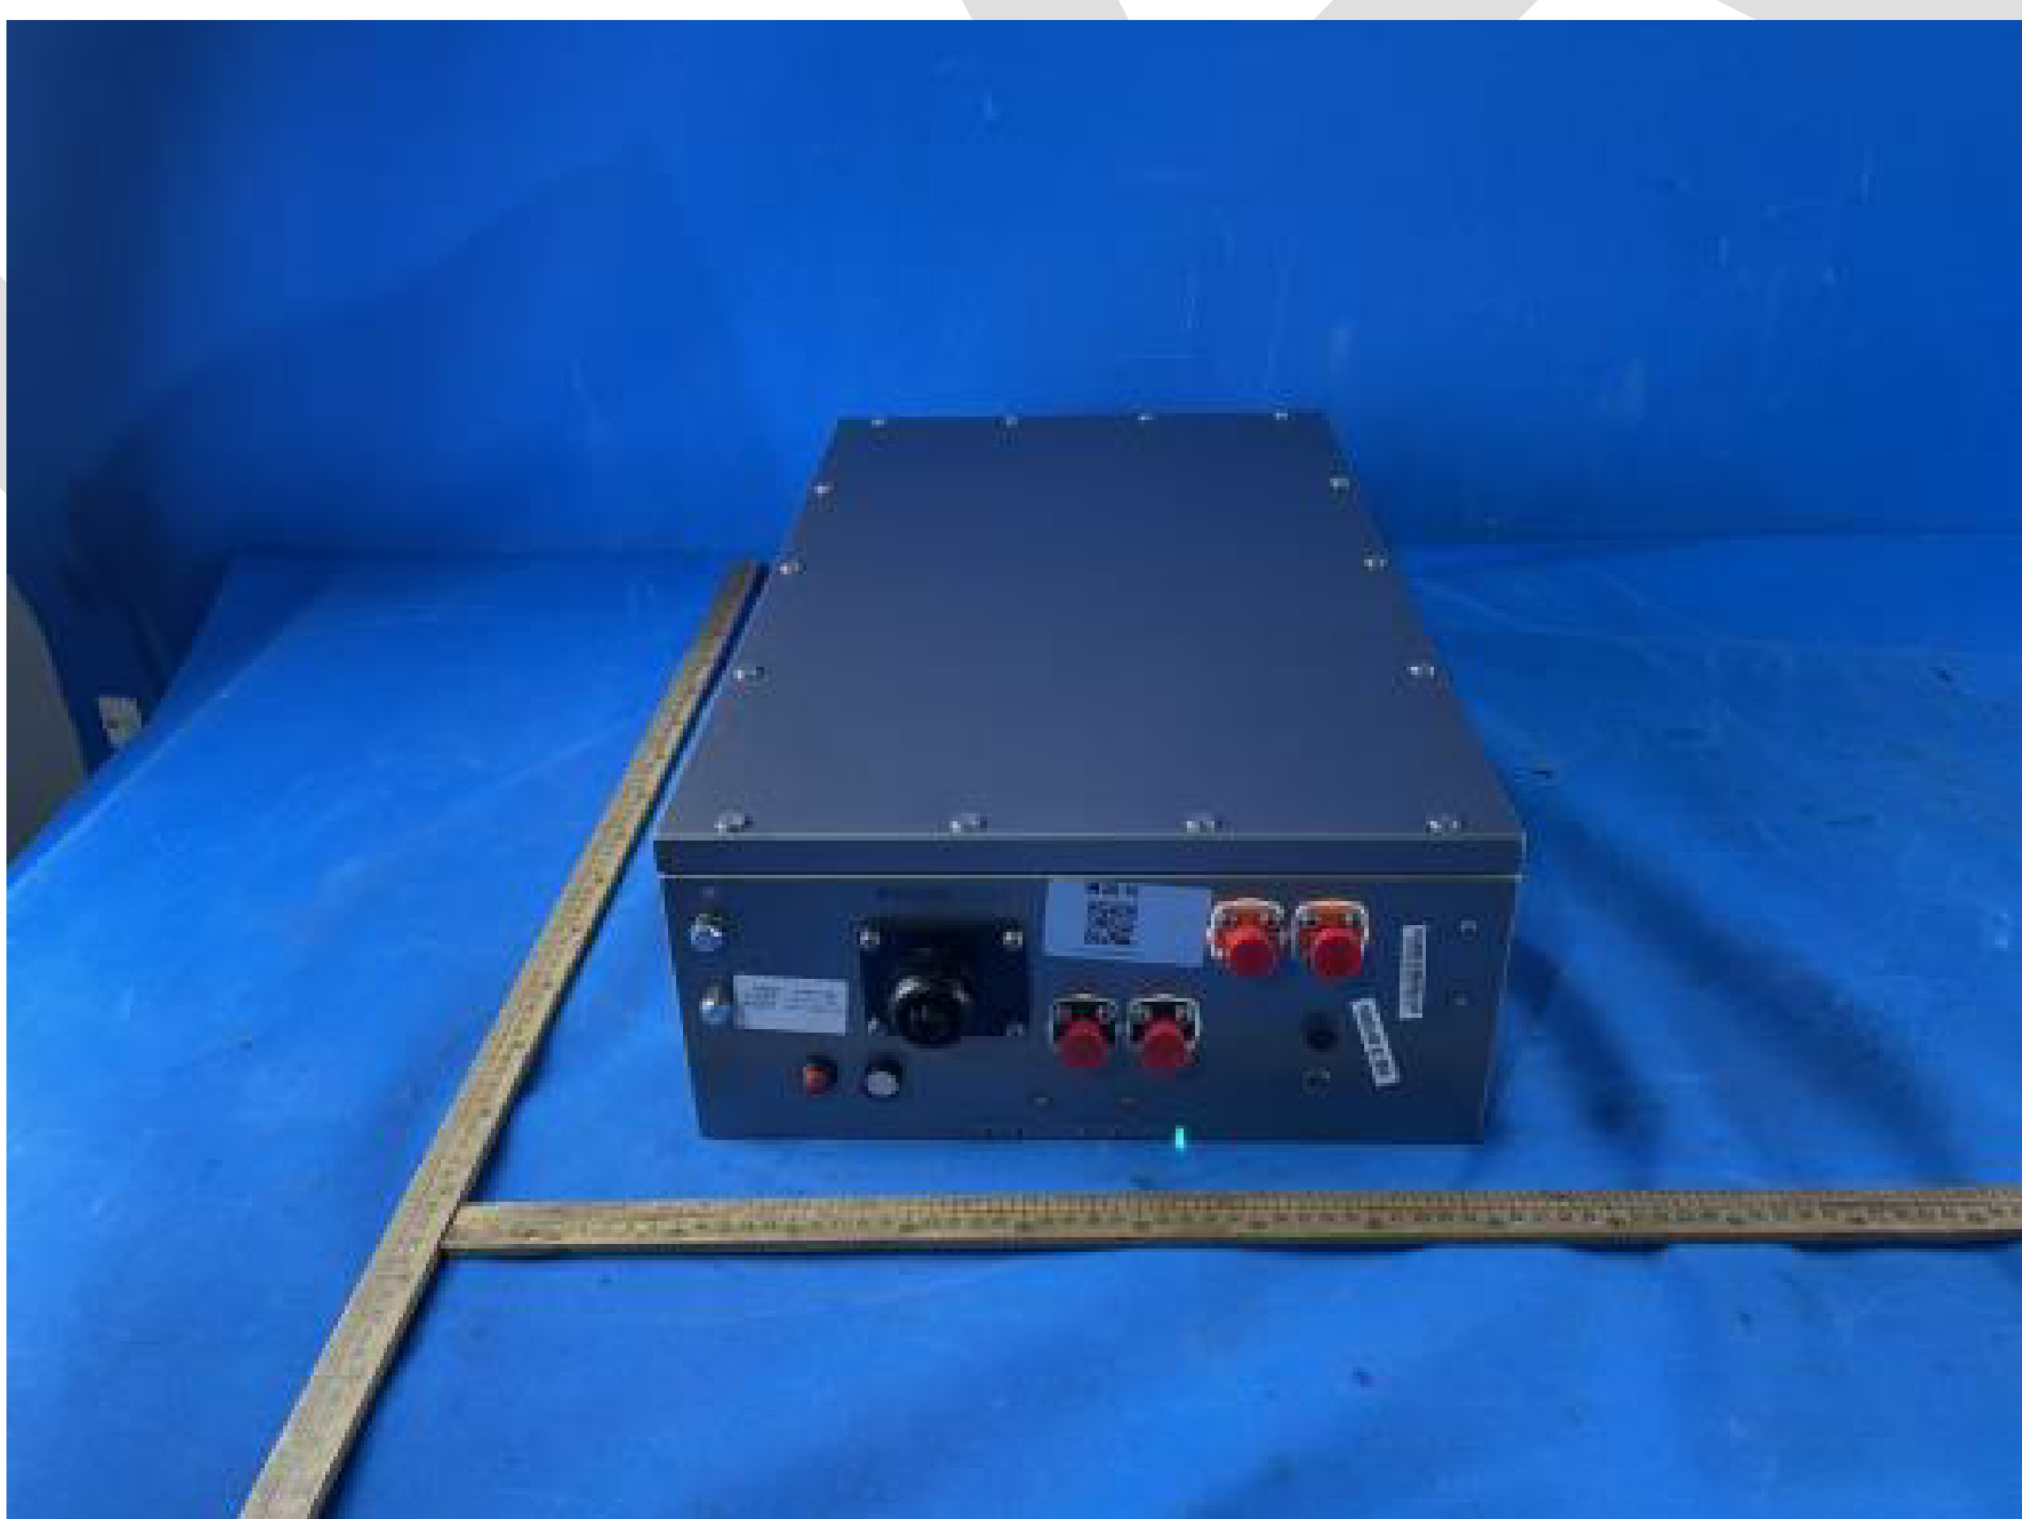
Fig.R03.5 After the test

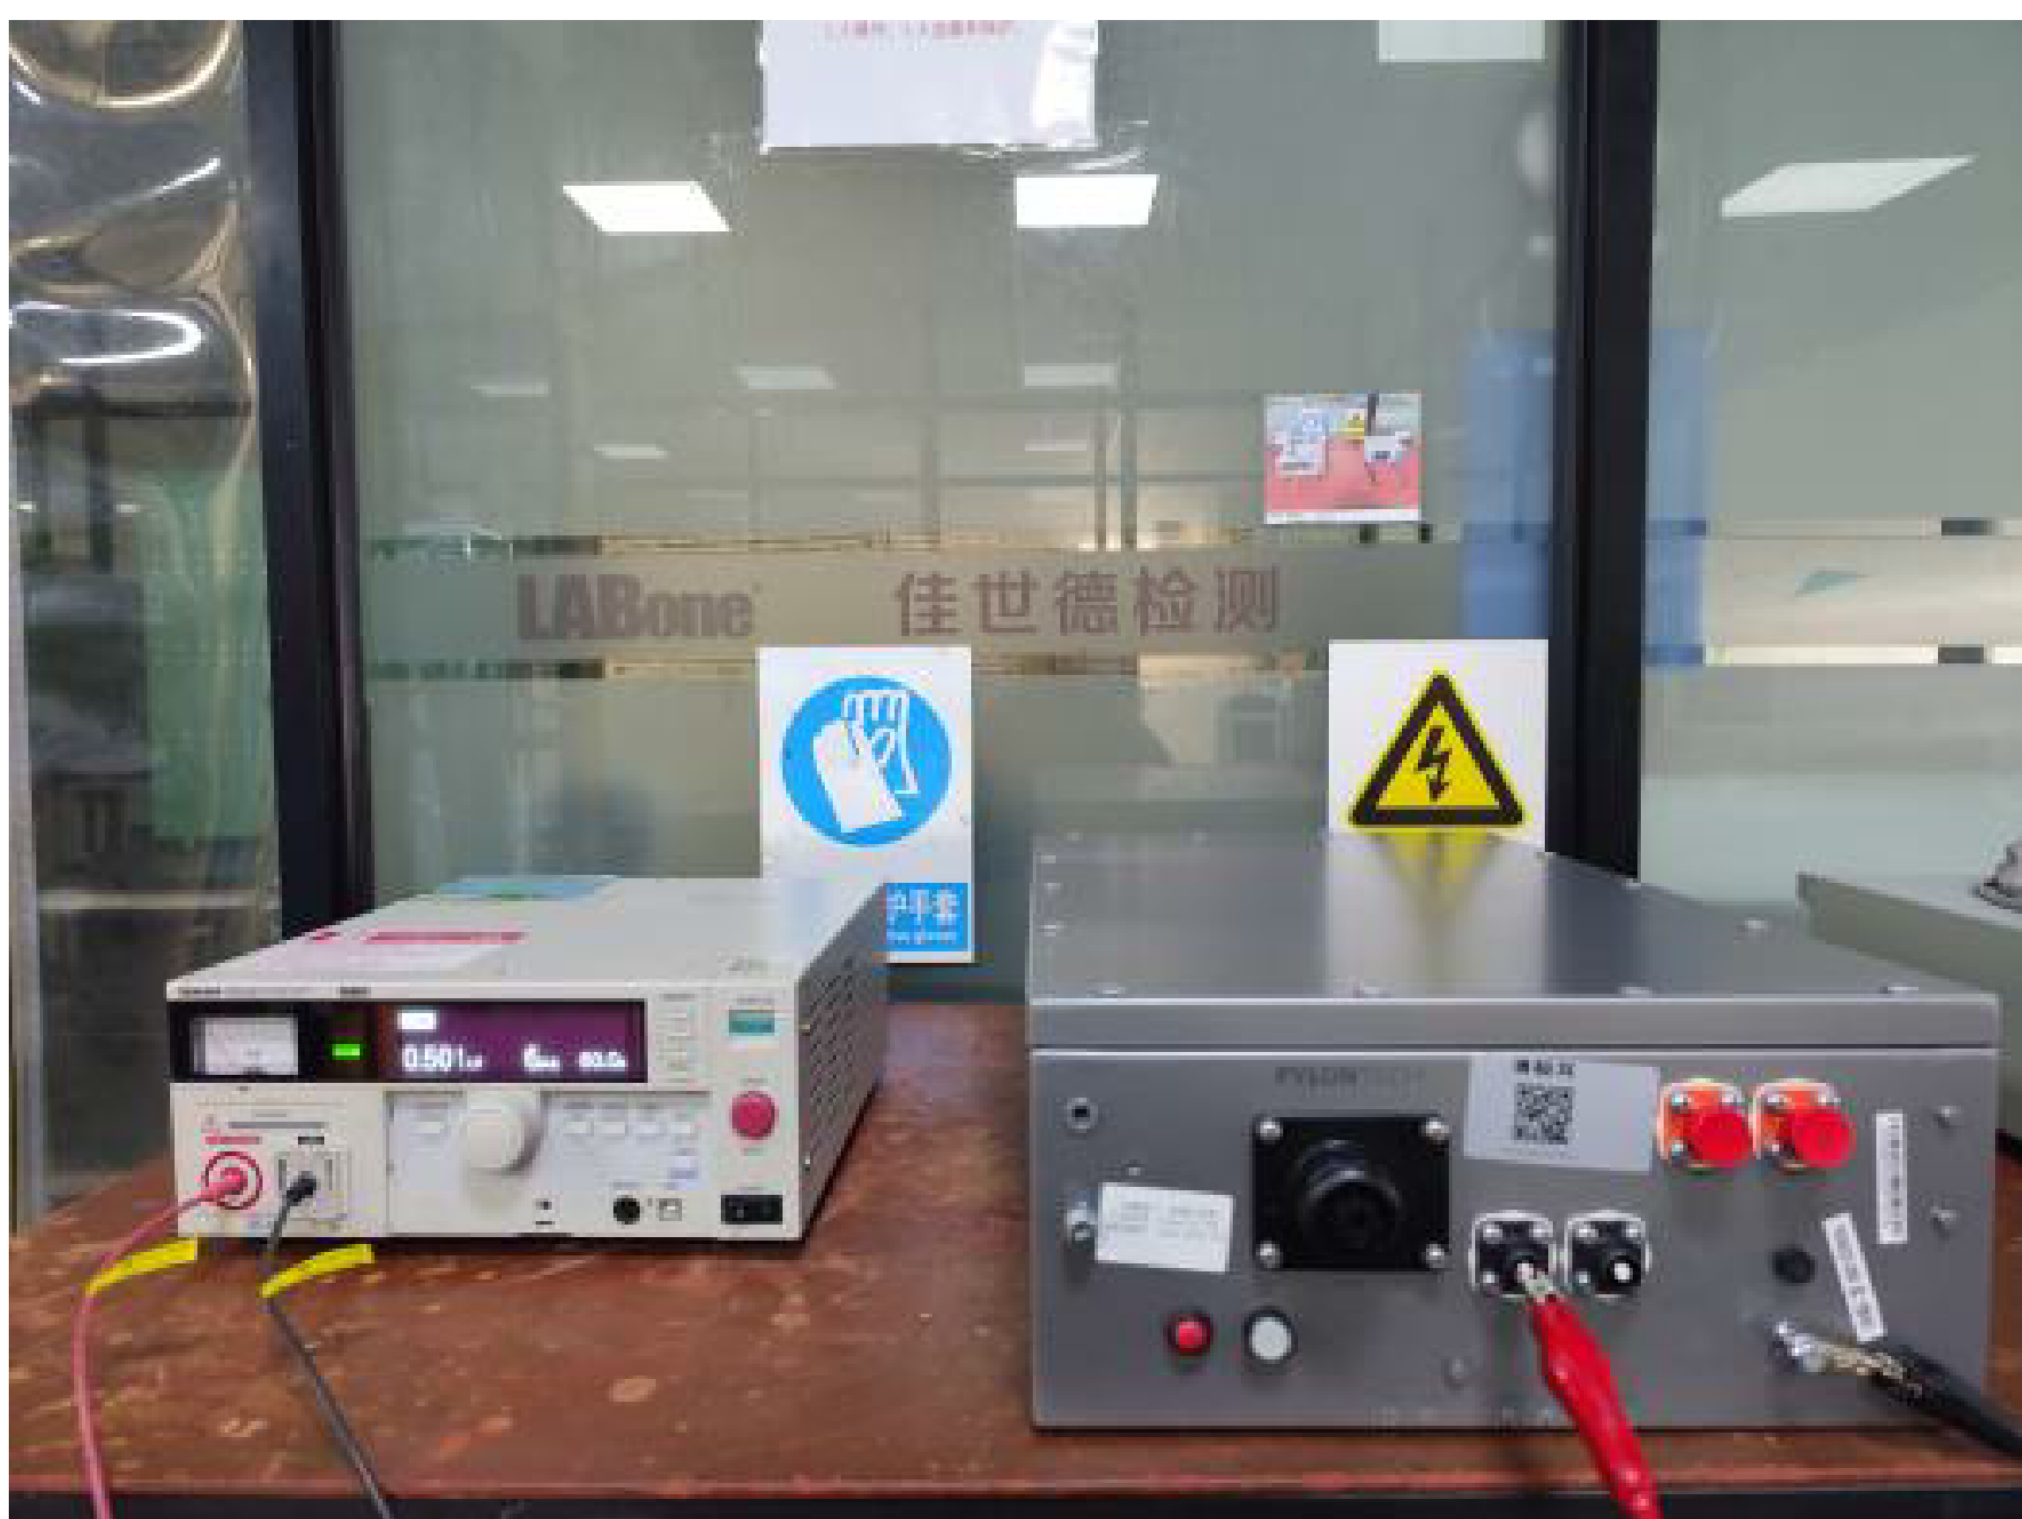
Fig.R03.6 After the test  
Leakage current is 6  $\mu$ A.
