Dr. Zapfe GmbH

Test documentation 2020-002

Load bearing tests on the Eco A roof hook
for the installation of photovoltaic systems
on pitched roofs

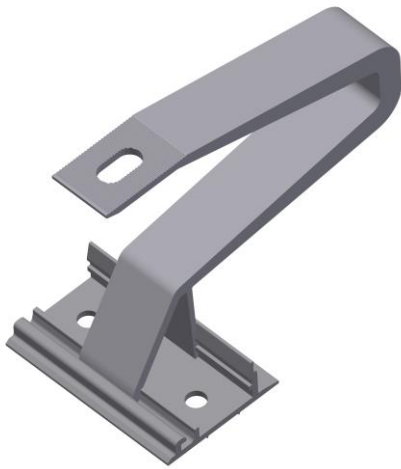
The subject of the tests documented below are load bearing tests on roof hooks of the product line EcoA manufactured by Schletter Solar GmbH. This is a roof hook consisting of two extruded profile sections which are connected by a form-locking snap-in connection with prestressing.

Fig. 1 Isometric view of the roof hook

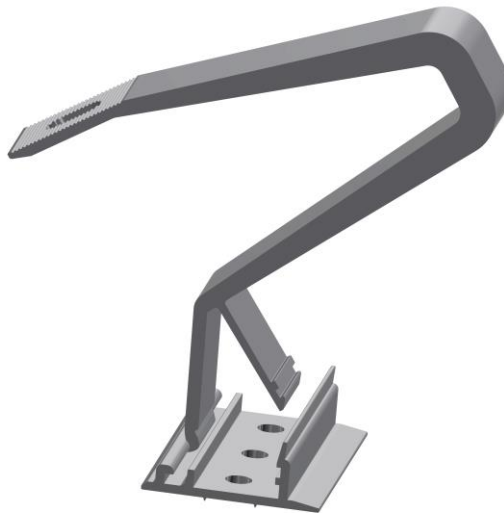
Fig. 3 Snap-in mechanism

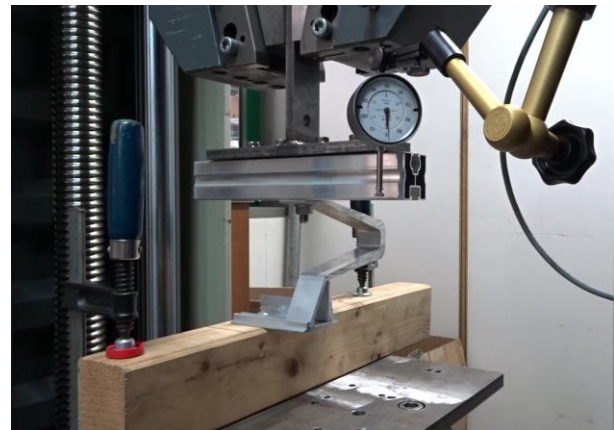
For the examination of the tensile strength in eccentric position, the roof hook was mounted with a screw on the bottom side on a wooden beam fixed in the machine. The load was transmitted via a cross beam in the screw channel of the module bearing profile mounted above. In the course of the test, the opening of the retaining bracket increases as the load increases, and at higher loads an uplifting of the mounting plates on one side occurs. This uplifting creates a leverage effect, resulting in increased local pressing on the wooden beam. These, however, do not cause critical damage to the wooden substructure.

Fig. 8 Assembly at the beginning of the test

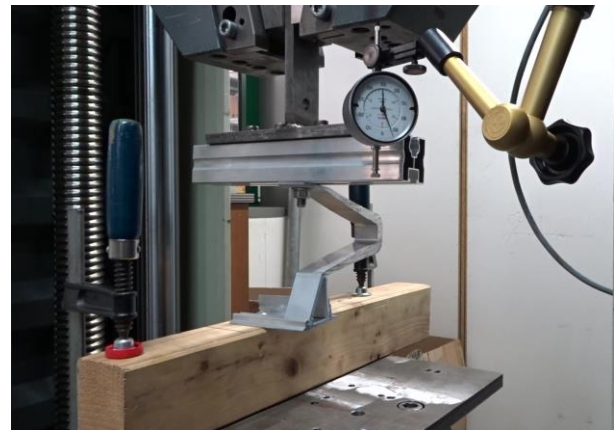
Fig. 10 Test-setup at 1,4 kN

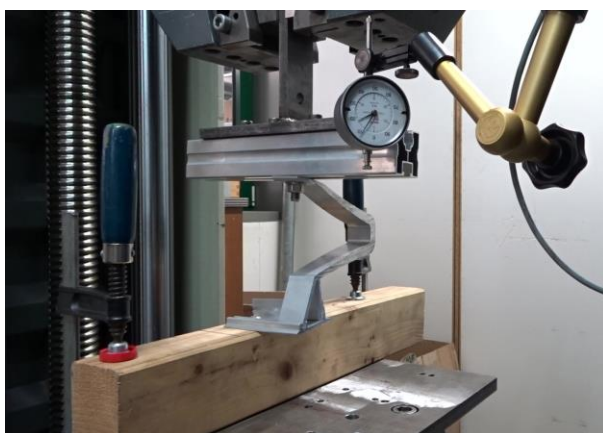
Fig. 11 Test-setup at 1,8 kN

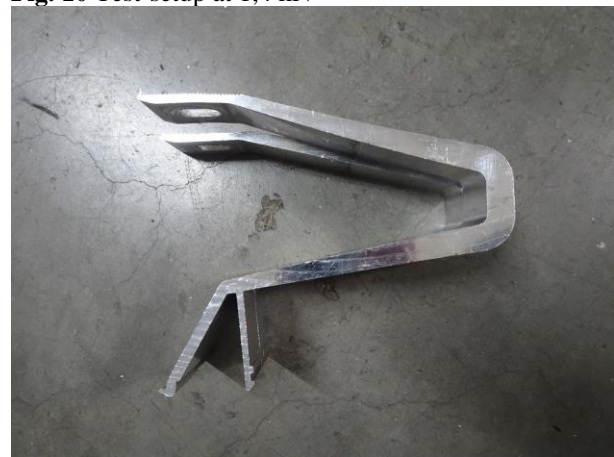
Fig. 12 plastic deformation after 45mm traverse path

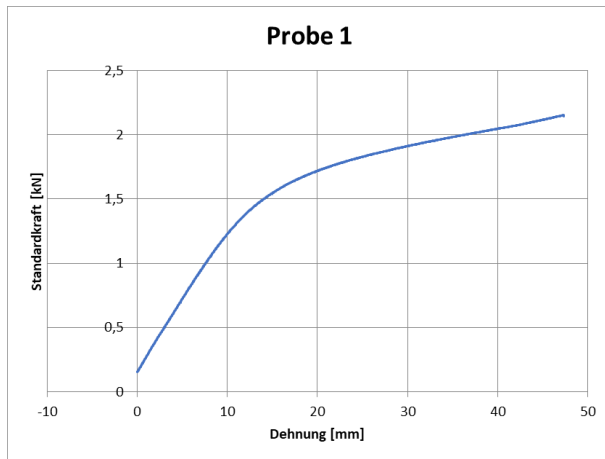
For the examination of the tensile strength in centric position the roof hook was mounted with a screw on the bottom side on a steel plate fixed in the machine. The tentative test shows that the load bearing capacity does not differ significantly from the eccentric position.

Fig. 13 Measuring record of the tentative test

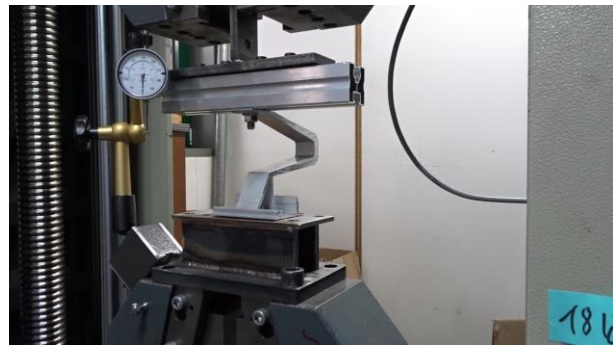
Fig. 14 Assembly at the beginning of the test

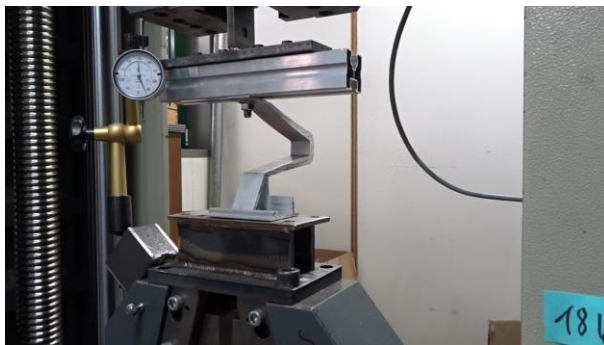
Fig. 15 Test-setup at 1,5 kN

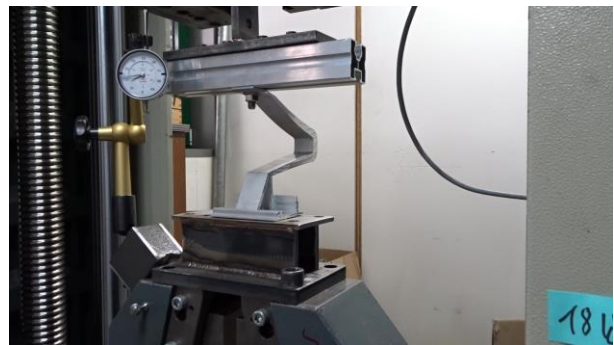
Fig. 16 Test-setup at 1,7 kN

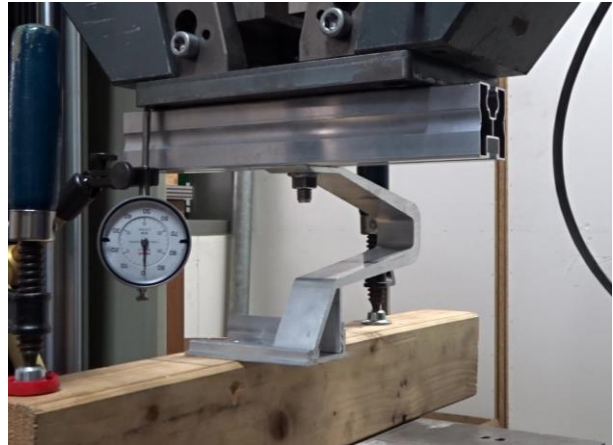
Fig. 18 Assembly at the beginning of the test

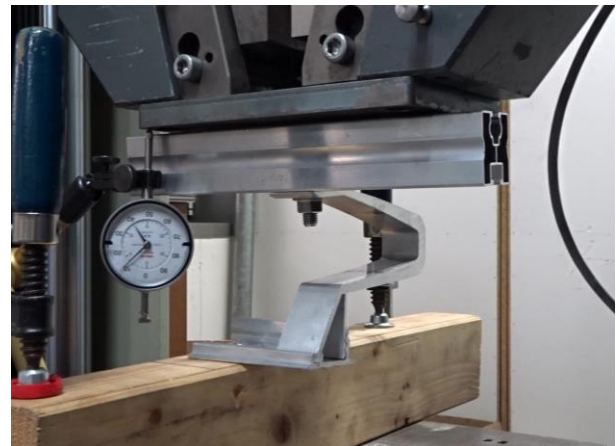
Fig. 20 Test-setup at 1,5 kN

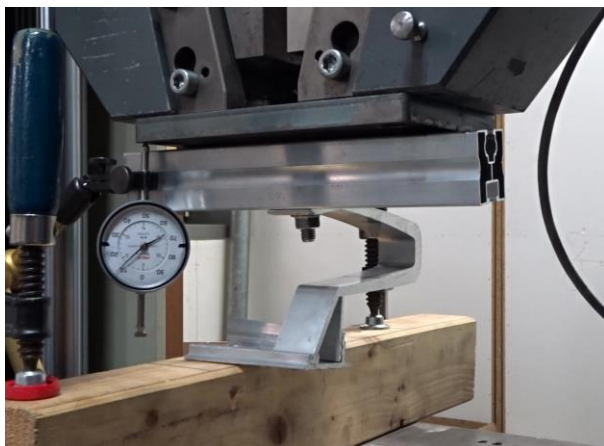
Fig. 21 Test-setup at 1,8 kN

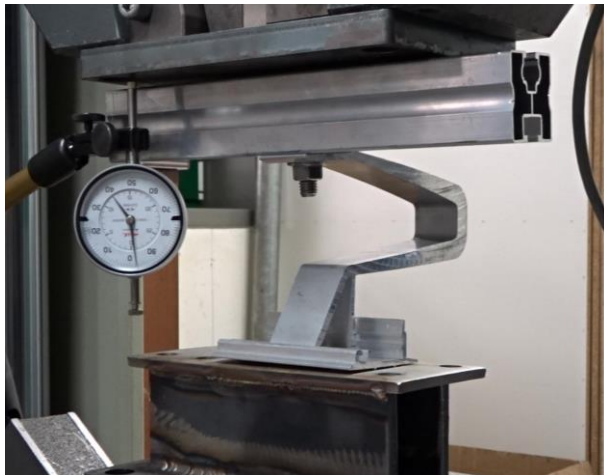
Fig. 25 Test-setup at 1,7 kN

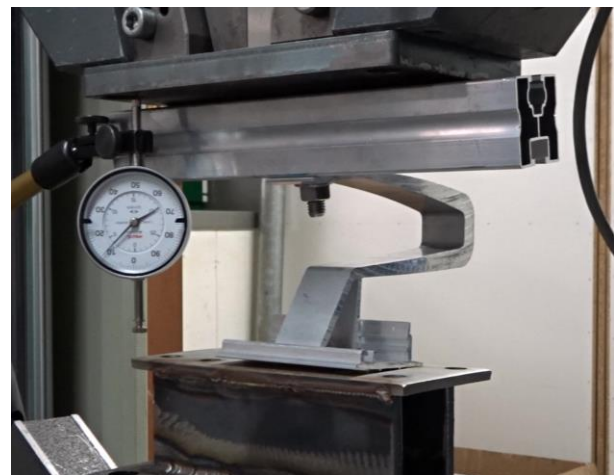
Fig. 26 Test-setup at 2 kN

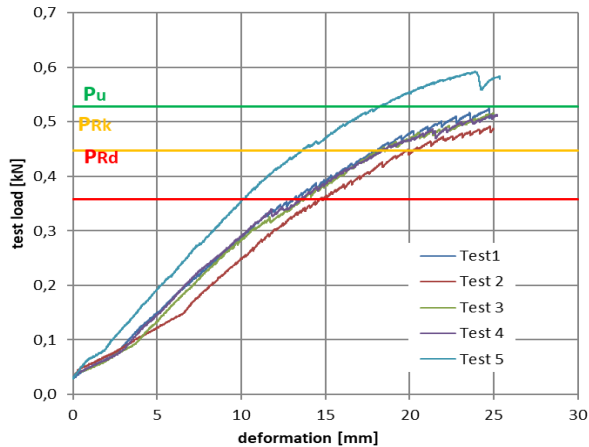
The shear strength test was carried out exclusively mounted on a wooden beam. Since the torque caused by the eccentricity acts around the longitudinal axis of the screw, with this type of loading it must be ensured that the rills under the base plate can wedge into the substructure. With increasing load the retaining bracket bends in the direction of the wooden beam.

Fig. 27 Measuring records of the shear tests

The measurement records of the shear tests including the statistical evaluation to deduce characteristic values of the pressure capability and of design values are displayed in figures 27 and 29. The statistical evaluation is based on EN 1990 Annex Z. The partial safety factor for the resistance side is $\gamma_M = 1.25$.

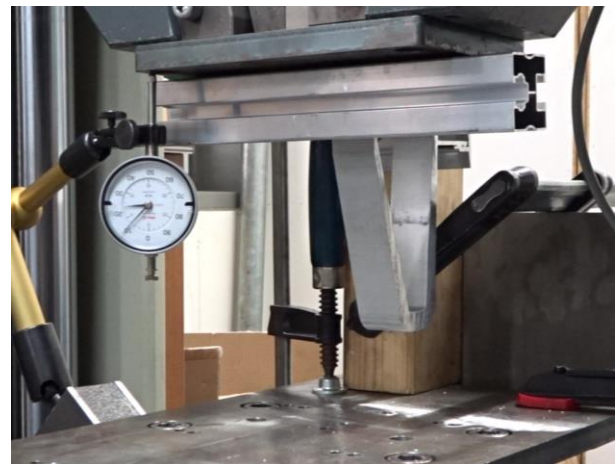
Fig. 30 Test-setup at 0,2 kN
